### Metal Concentrations in Fish and Shellfish of the Avon-Heathcote Estuary/Ihutai and Rivers: 2008

Prepared for Environment Canterbury

EOS Ecology Report No. 08002-ENV01-01 June 2008

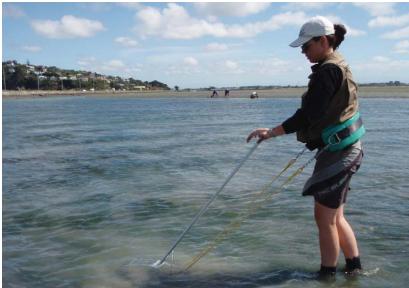
The cockle rake in use at the causeway site

Cockles were collected at low tide using a cockle rake and by hand. The cockle rake is pulled through the sediment and separates out the cockles. The cockles were kept cool with ice packs, their length measured, and then delivered live to Hill Laboratory for analysis. Ten samples per site (of three to five cockles per sample, depending on size) were analysed for mercury, and five samples per site for arsenic, lead, and cadmium.

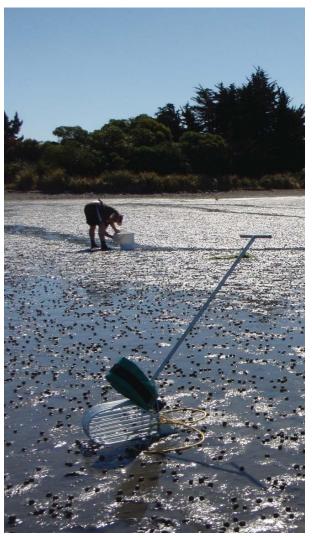
Collecting cockles near the Bromley Wastewater Treatment Plant discharge. The cockle rake is in the foreground

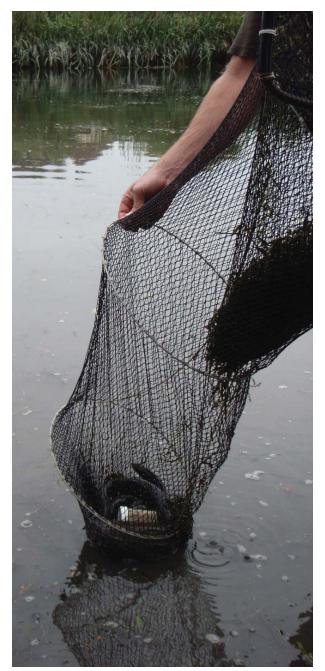
A fyke net full of eels from the Avon River

Shortfin eels were collected from the Heathcote River and Avon River using Fyke nets. These nets are a series of hoops connected by mesh. Once the fish enter the inverted funnel entrance they can't find the narrow exit and are trapped. These nets were baited and left overnight. The next day the eels were anaesthetised, their length measured, and either taken to Hill Laboratories for analysis or returned to the river if too many were caught. Mercury levels were tested in ten eels and arsenic and lead in five eels.

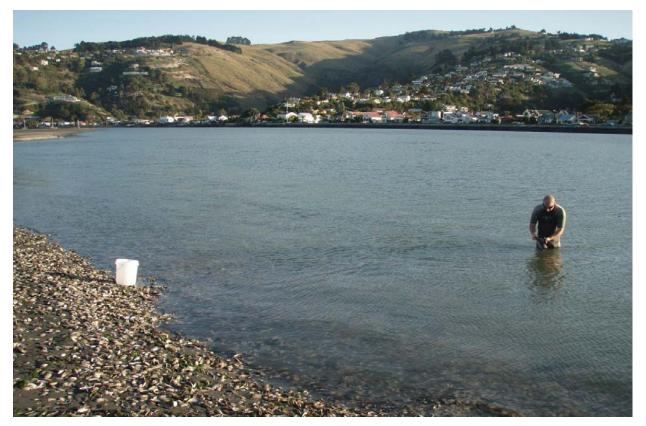
Collecting pipis near the estuary mouth

Pipis were difficult to find and multiple sites were searched near the estuary mouth before a live population was located, in the low-tide channel opposite the Beachville Road corner. Pipis were not especially abundant and were of a small size, despite the presence of a large number of big empty shells.

Pipis were collected by hand, kept cool with ice packs, their length measured, and then delivered live to Hill Laboratory for analysis. As with cockles, ten samples per site (of five pipis per sample) were analysed for mercury, and five samples per site for arsenic, lead, and cadmium.
