# Ecological Values and Wildlife Opportunities *of the* ***Lower Heathcote Valley Floodplain***

Report for Parks & Waterways Unit  
Christchurch City Council

Andrew Crossland  
Parks & Waterways Unit. March 2003

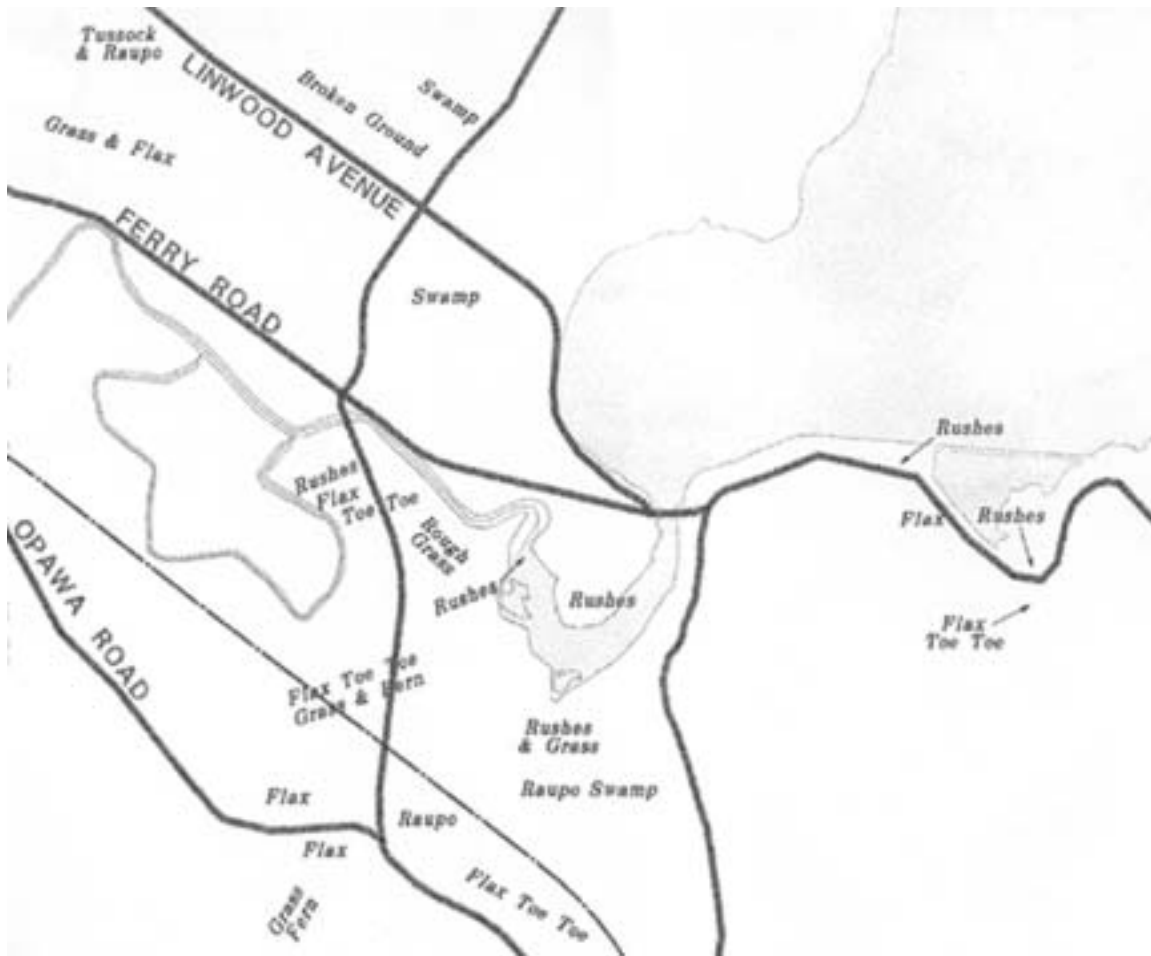
Figure 3. Part of the Black Maps showing the study area and environs

In summary, the 1840's – 1850's landscape involved a band of tidal wetland habitats along the Heathcote river, comprising mudflats and muddy riverbanks with margins of dense rushes. This is not too dissimilar to what is found in the Heathcote Loop today, except that vegetation cover was formerly denser and much more extensive. On the true left bank the margin of rushes gave way to taller *Plagianthus* saltmarsh, and on the true right bank to freshwater raupo swamp, rough native grasses, flax, toe toe and bracken fern.

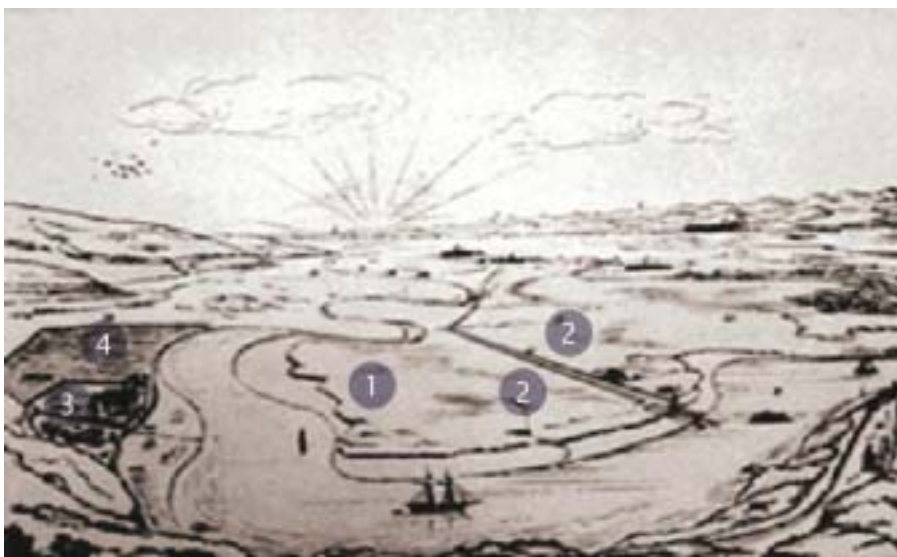
**Figure 4. 1851 Painting showing the Lower Heathcote Valley Floodplain**  
(CML collection)

Note: the artist's depiction of extensive areas of marsh and swampland along the river (1) and on both sides of Ferry Road (2). The early stage of European settlement is shown by a cluster of buildings at Ferrymead (3) and a small adjacent area of cultivation (4).

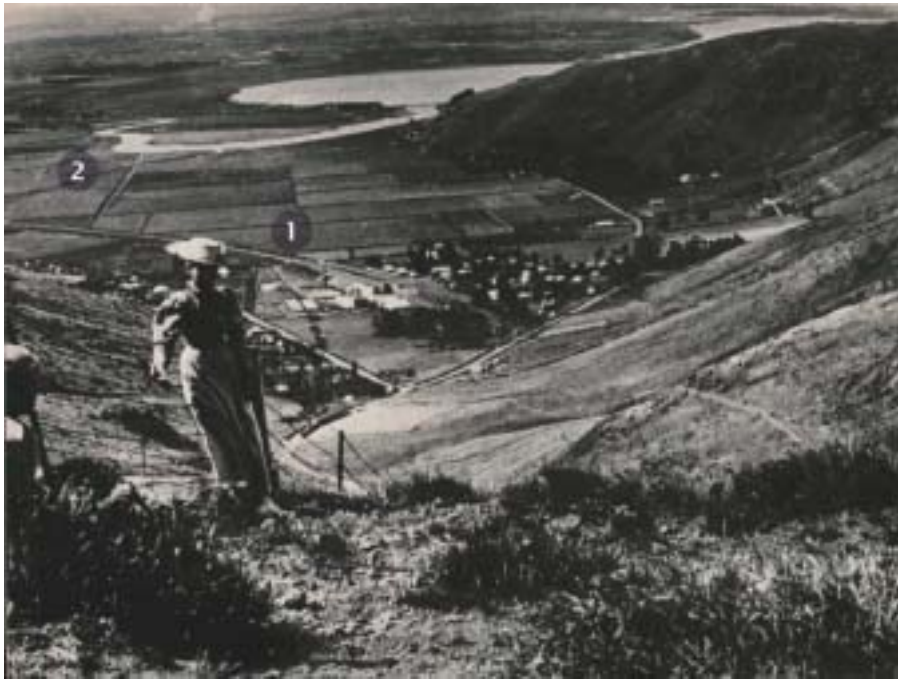
Figure 6. A photograph of the same view, taken about 1880. (CML collection)

Note that the valley is "*squared into many-coloured fields*" as Samuel Butler described, and that wetland areas are restricted to riparian areas beside the Ferrymead Branch Railway Line (1) and around the original mouth of Avoca Valley Stream (2).

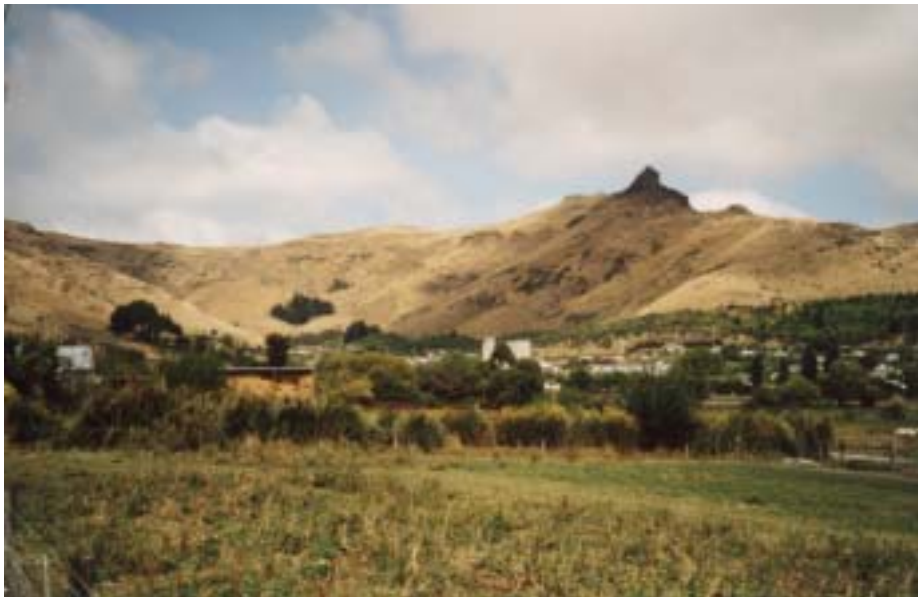
**Figure 10. Present day (2003) photo of approximately the same view as shown in fig. 9.** (photo: A Crossland)

Note: that this part of the valley is now largely settled and well vegetated with garden and parkland trees. Poor quality grassland (mainly used as horse paddocks) remains the principal ground cover in the lower part of the valley and seems little changed in 140 years.

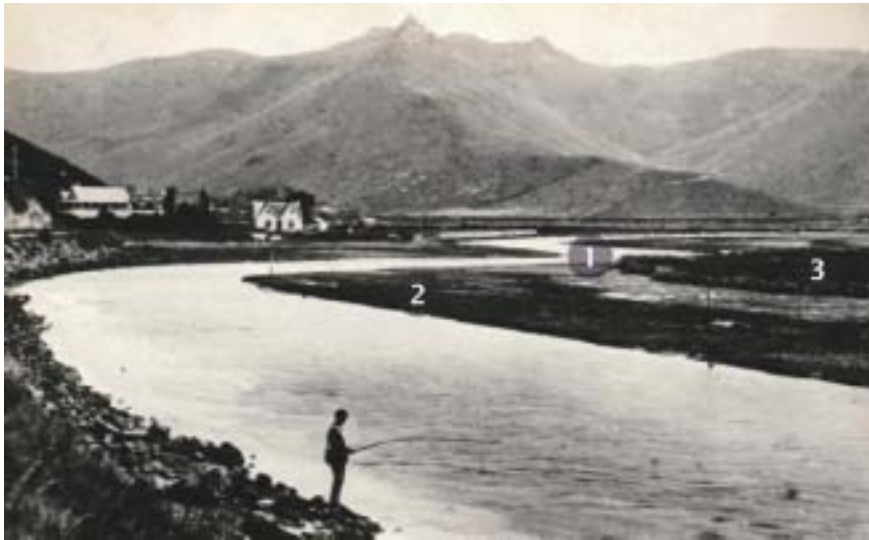
**Figure 12. An 1880 view of the lower Heathcote Loop looking across to the Ferrymead shoreline and the present Avoca Valley Stream mouth**  
(Alexander Turnbull Library)

Note the sinuous course of the low-tide channel (1); the extensive weed beds (probably eelgrass or *Gracilaria*) covering the mudflats (2); and the thick density of the sea rush saltmarsh opposite with no obvious edge erosion or dieback (3).

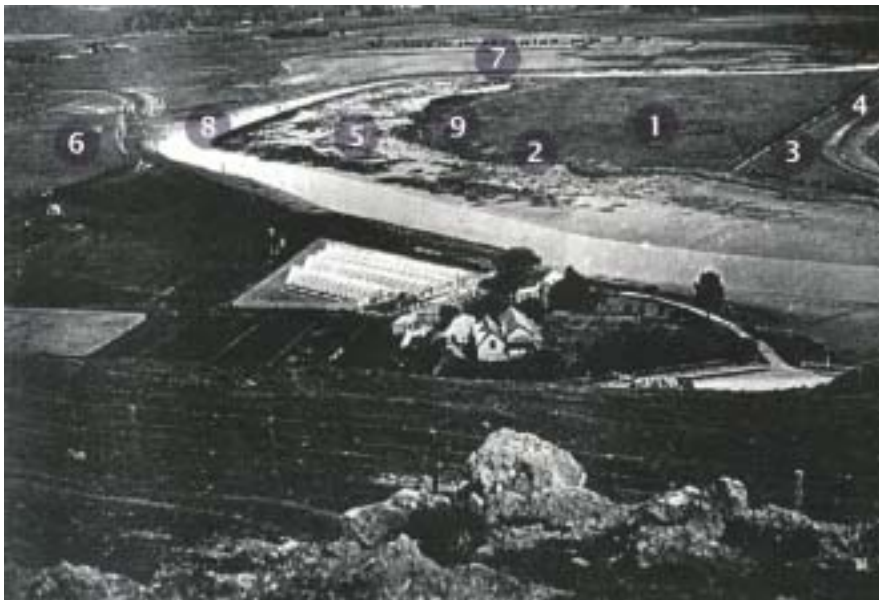
**Figure 13. Heathcote Loop sometime after 1910** (CPL collection)

Note: dense growth of sea rush in Heathcote Loop saltmarsh (1); the early stages of formation of a single meandering tidal creek draining the saltmarsh (2); an intact embankment around the racecourse with no signs of erosion (3); the parallel tracks of the old racecourse (4); weed beds (presumably of eel grass or *Gracilaria*) lying between low tide channel and the saltmarsh (5); small tidal creek inlets inland of the railway line (6); the dark coloured swale of the original Avoca Valley Stream channel, passing through what appears to be cultivated land or pasture with a line of small trees or shrubs beyond (7). Note also that the low tide channel of the Heathcote River is very narrow and hard up against the edge of the true right bank (8). Some erosion of the saltmarsh edge or a strand zone (perhaps of driftwood) is evident (9) (see figure 16). Note that this was not evident in the 1880 photograph shown in figure 12.

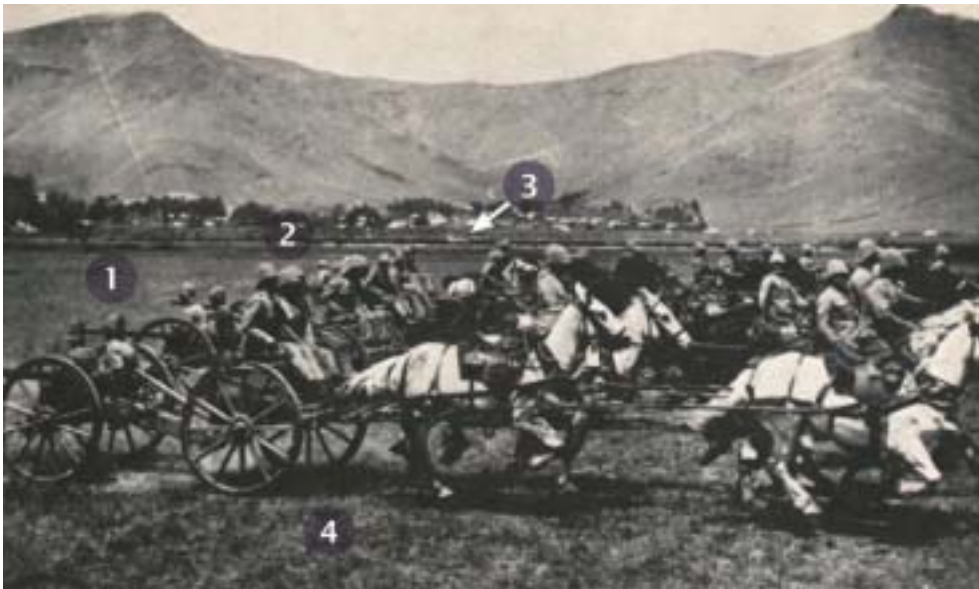
**Figure 14. 1904 photograph of horses on the old Heathcote racecourse site looking south** (Guy Bliss, from Ogilvie 1978).

Note: The “action” depicted in the photograph is taking place on the edge of the Heathcote Loop Saltmarsh. A uniform and dense expanse of sea rush can be seen stretching to the river edge (1). The opposite bank also appears to have saltmarsh margins (2) and there is little evidence of human activity aside from what appears to be small building or possibly jetty in the centre of the photograph (3). The short-turf under the horse’s feet (4) is probably *Sarcocornia*-dominated salt meadow. Most of this area was vegetated in a mix of *Sarcocornia* and grass up until it was reclaimed in c. 1985-1986. Note the absence of trees at this date along the landward margin of the saltmarsh.

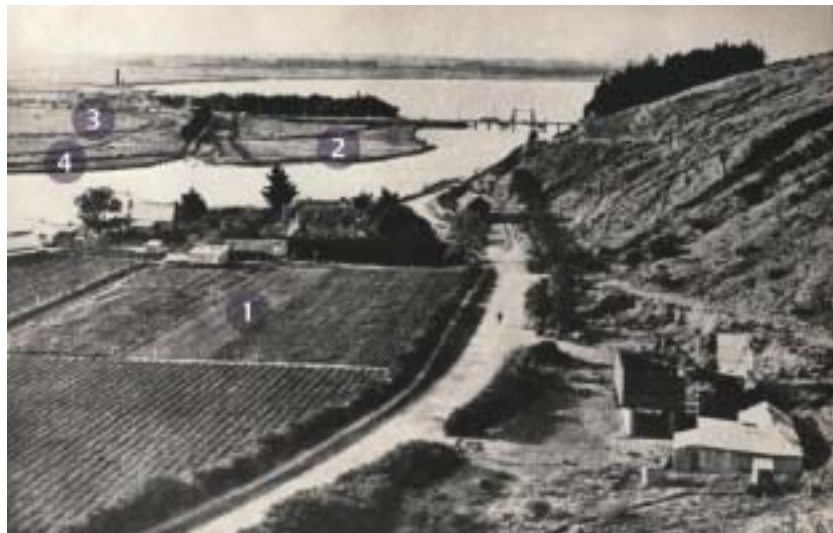
**Figure 15. 1911 photo looking across Ferrymead and part of the old racecourse site** (Weekly Press, CPL collection)

Note: Heavy cultivation on the land behind the Ferrymead wharf buildings (1); intact and dense saltmarshes across the river (2); and the presence of a new northern track at the racecourse, with the older southern track still evident (3) and still protected by a bund (4).

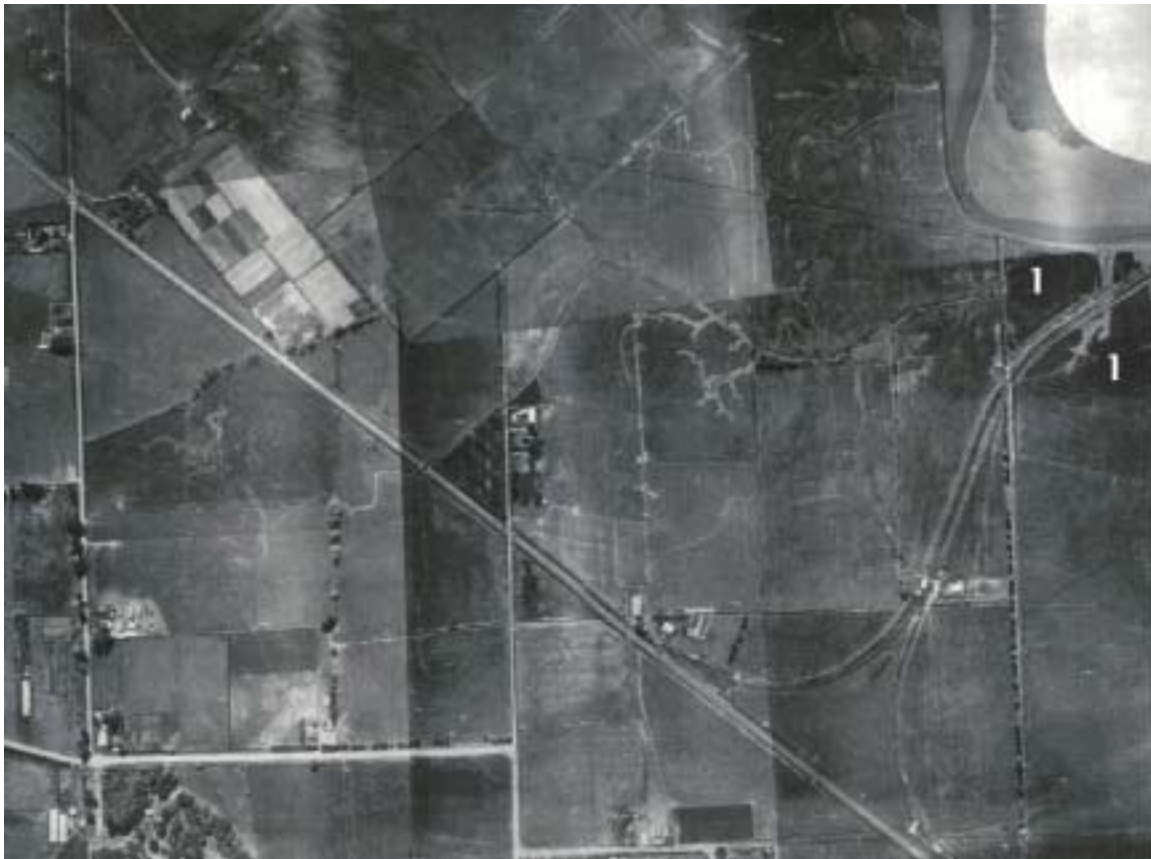
**Figure 16b. 1926 Aerial photo of the lower valley**

Fence lines and shallow drainage ditches indicate that attempts were made at some date prior to 1926 to convert most of the Lower Heathcote Floodplain into farmland. Areas apparently still untouched at this date were Ferry Road Saltmarsh, Devils Elbow Saltmarsh, Stilt Island Saltmarsh, Heathcote Loop Saltmarsh, and Ferrymead Saltmarsh, including marshland on both sides of the Railway embankment (1). Many old tidal creeks and waterways are evident throughout the valley.

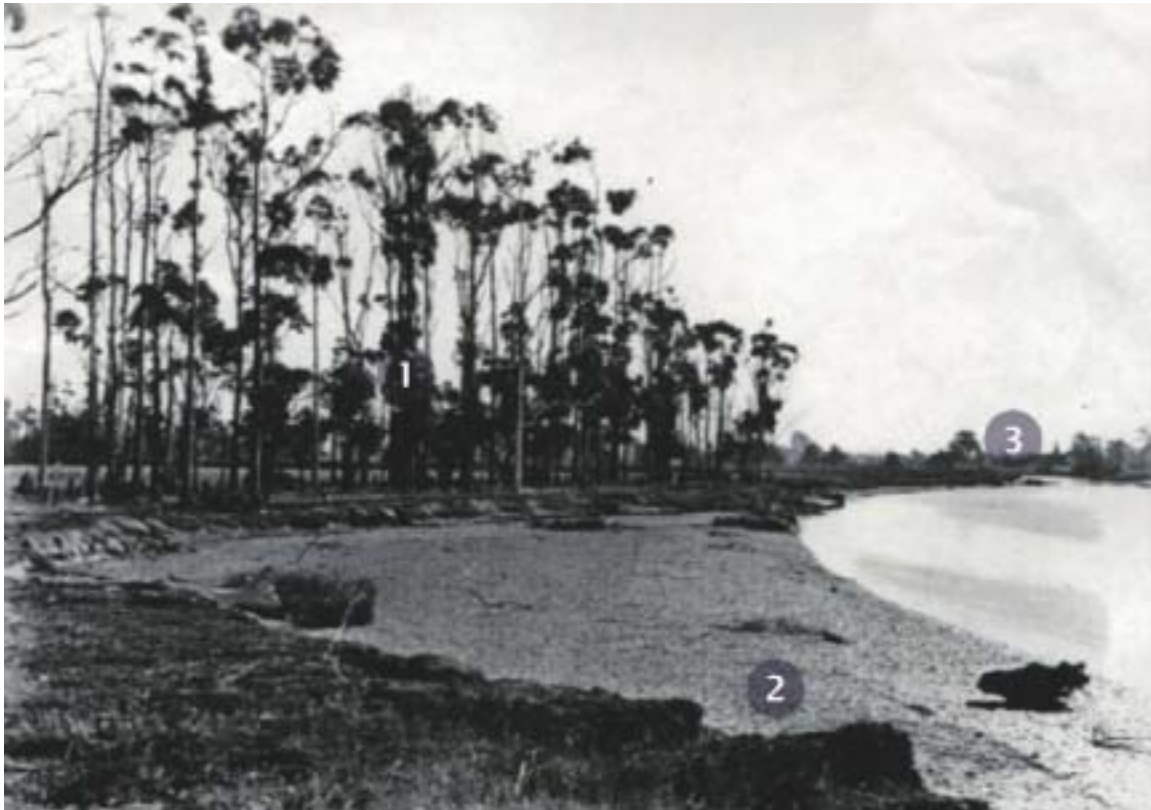
Figure 17. c.1920's photograph of Heathcote Loop looking from Stilt Island Saltmarsh to Devil's Elbow (W.A. Taylor, CML collection)

This is one of a series of photographs taken by W.A Taylor of various bends and reaches of the Heathcote River from the upper reaches to the Heathcote Loop, comprising a very useful historical record. Note the line of young Eucalypts (1) (judging by size they were probably planted in the 1910s) and the eroding edges of the saltmarsh (2). The dense area of sea rushes comprising Devil's Elbow Saltmarsh can be seen beyond the trees (3).

Note: the disappearance of saltmarsh along the river banks – dredged fill material now comprises the riverbanks and native vegetation has been planted as part of enhancement work. Note also that the two stands of Eucalypts shown in fig. 18 still stand (now approx. 100 years old) and are surrounded by more recent pines. The Eucalypts shown in fig. 17 no longer exist and pines have taken their place.

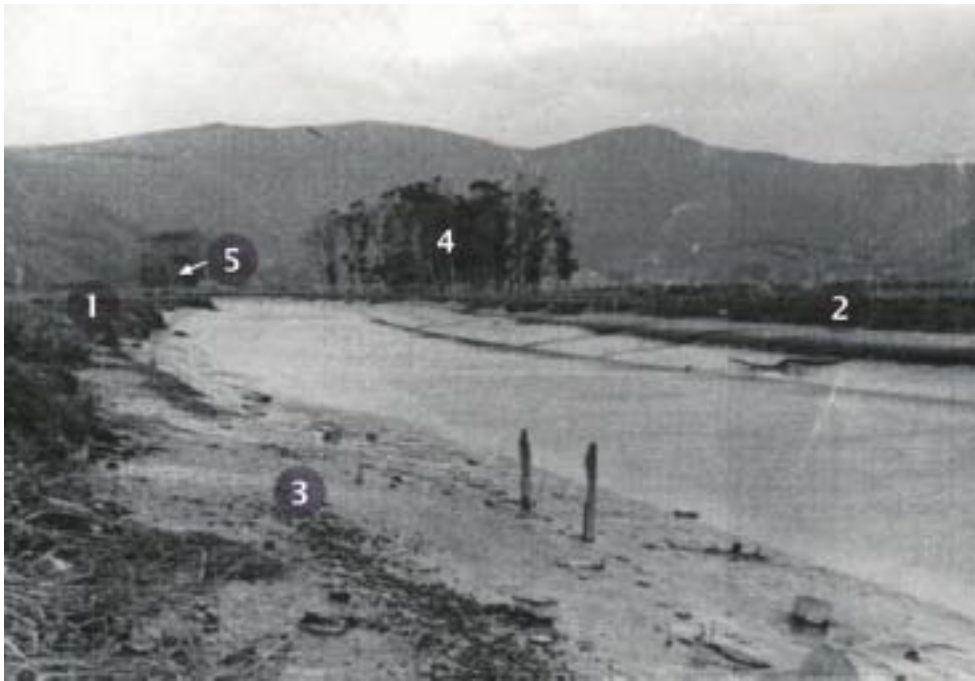
Figure 18. c.1920's view of the Lower Heathcote River just upstream of Ferry Road Saltmarsh toward the Devil's Elbow (W.A Taylor, CML collection).

Note: saltmarshes on both sides of the river (1,2); narrow marginal mudflats along the riverbanks (3) with remains of some former structure in the foreground – possibly a jetty. Note also the two stands of Eucalypts (4,5) which still exist (see fig 19.).

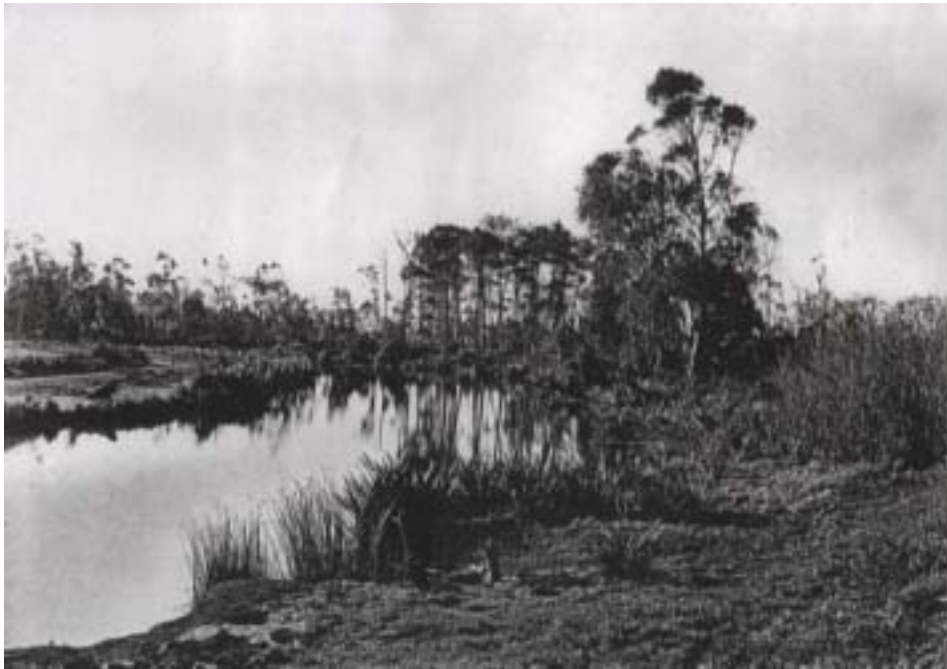
Figure 20. 1920's view of Heathcote river looking downstream at Kennaway Farm  
(W.A. Taylor, CML collection)

Note: young Eucalypts, flaxes and rushes. This stretch of the lower Heathcote River was located upstream of the saltmarsh zone. In the 1920's riparian habitats here appeared to retain some of the original vegetation cover – described as "*rushes, flax, toe toe*" in the Black Maps.

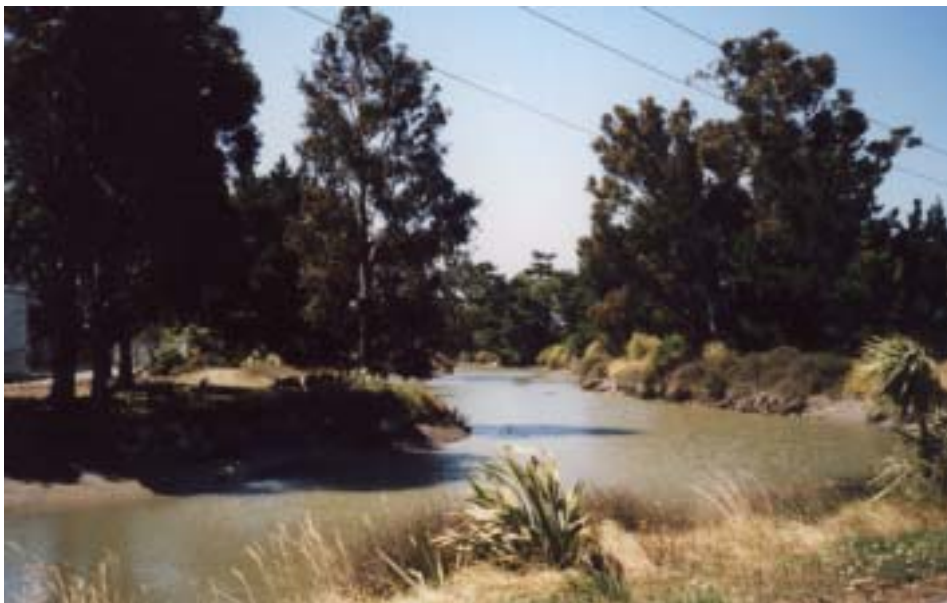
Figure 21. 2003 photograph of approximately the same view of the Lower Heathcote at Kennaway Farm as shown in figure 20  
(photo A. Crossland)

Note: The stand of Eucalypts (now close to 100 years old) still stands and in fact serves as an important night roost for cormorants (1). Several original marsh ribbonwoods (2) are still found on the riverbank, while much of surrounding riparian zone has now been successfully replanted with natives and a walking track has been built along the old tow path.

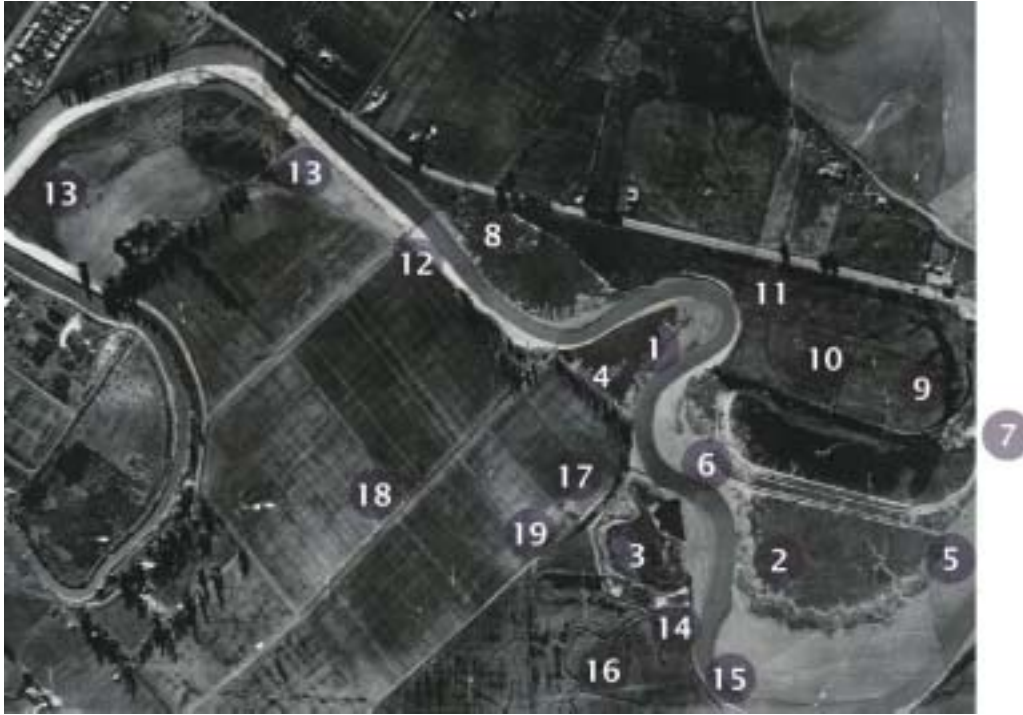
Note: Erosion and/or sea rush dieback in and around the edges of Devil's Elbow (1) Heathcote Loop (2), and Stilt Island (3) saltmarshes is clearly evident in this 1946 photograph. Note the disappearance of vegetation on the downstream sides of Ferry Road and Devil's Elbow saltmarshes, and on the upstream sides of Heathcote Loop saltmarsh – these are all areas where substantial volumes of drift wood tend to strand and the effects of smothering as well as possibly siltation may be causative factors. Increased siltation is evident with a build up of mudflats on each bend of the river and the total absence of *Gracilaria* or eel grass beds.

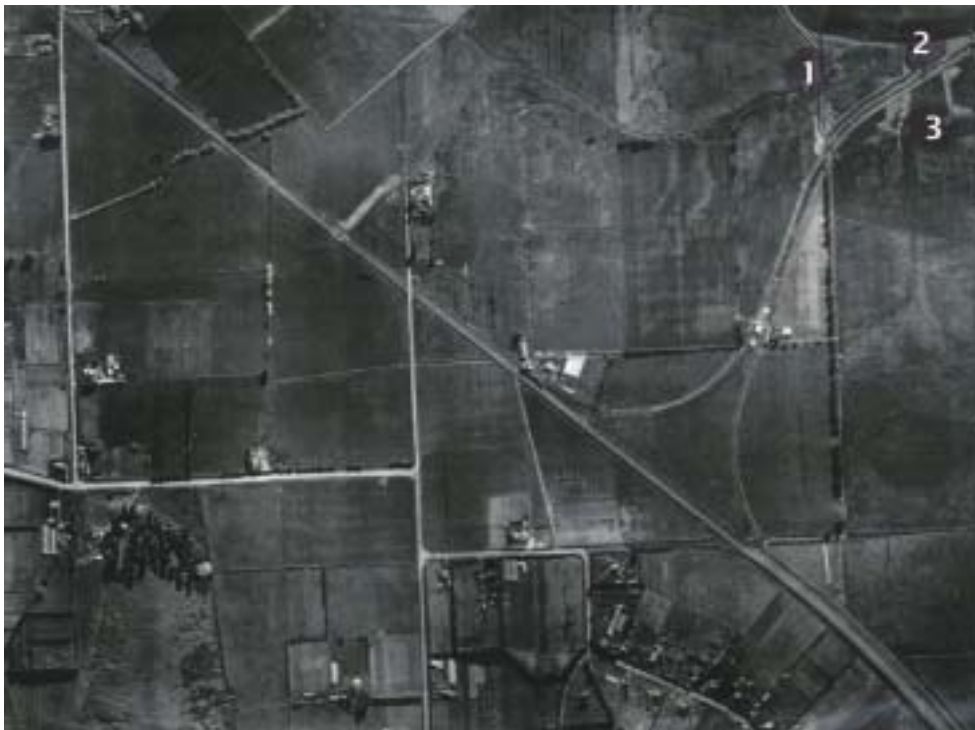
**Figure 23. May 1946 aerial photograph of Heathcote Valley** (NZ Aerial Mapping)

Note: A diversion ditch (1) links the old mouth of Avoca Valley Stream with a new mouth (2) in Ferrymead Saltmarsh. Tidal creek inlets (3) are evident on the landward side of the railway embankment, while depressions and swales marking many former channels are visible all over the lower Heathcote Valley floor.

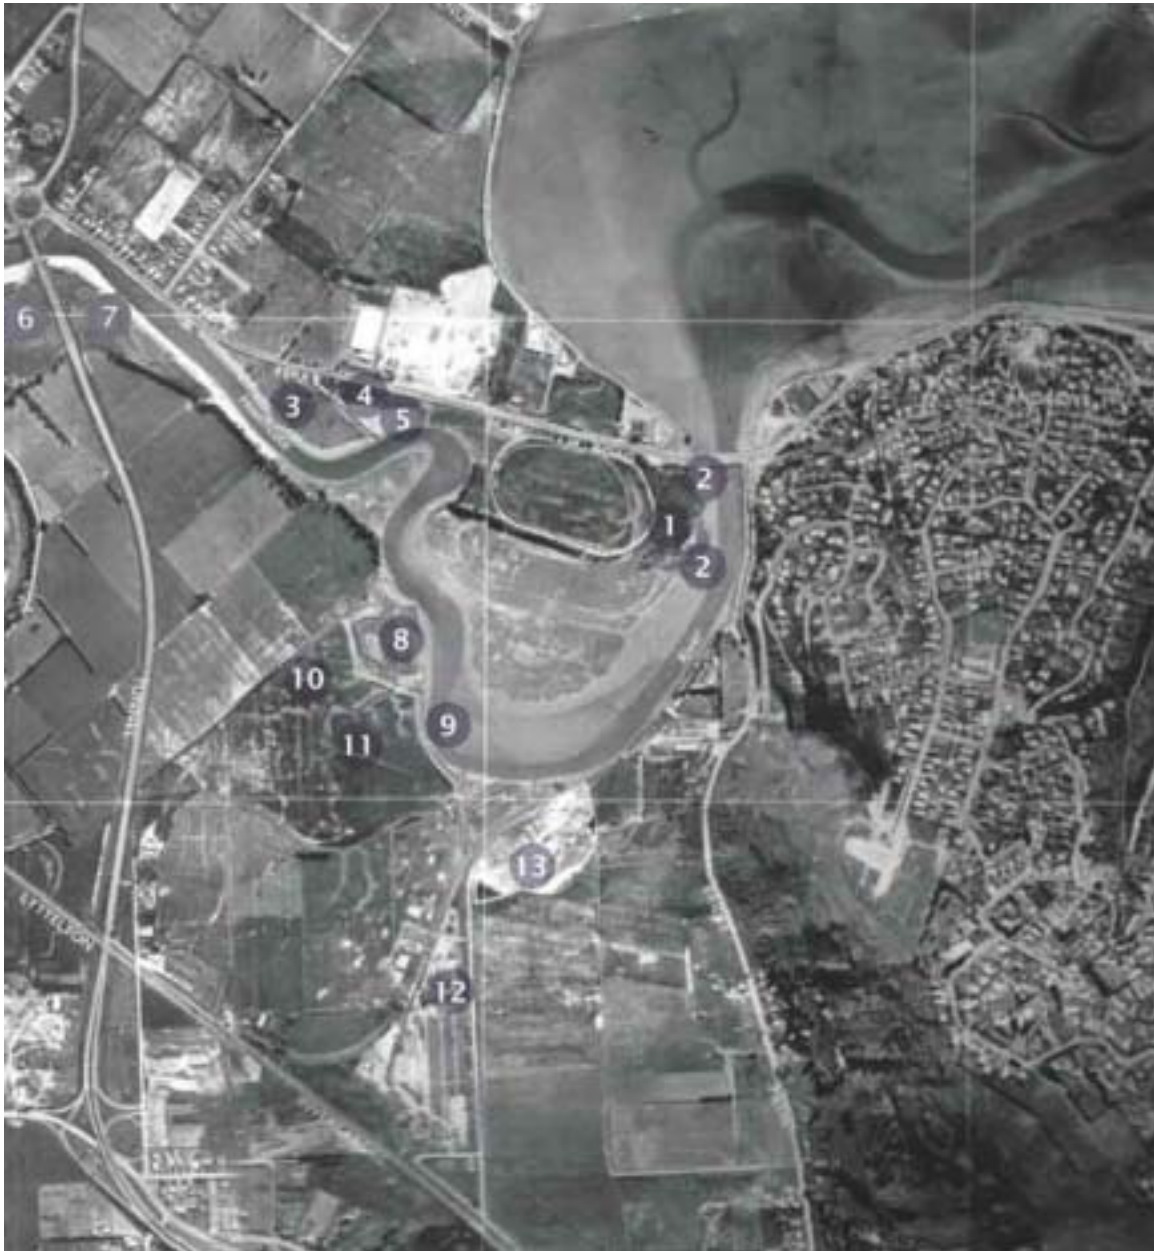
Note: This 1973 photograph appears to show a slight recovery in sea rush cover at Ferry Road, Devil's Elbow and Heathcote Loop saltmarshes, although slight erosion and/or dieback is evident around the edges of the latter two. The landfill (1) on the southern part of Ferrymead Esplanade Saltmarsh has ceased operation and only 2 small remnant patches of sea rush remain (2).

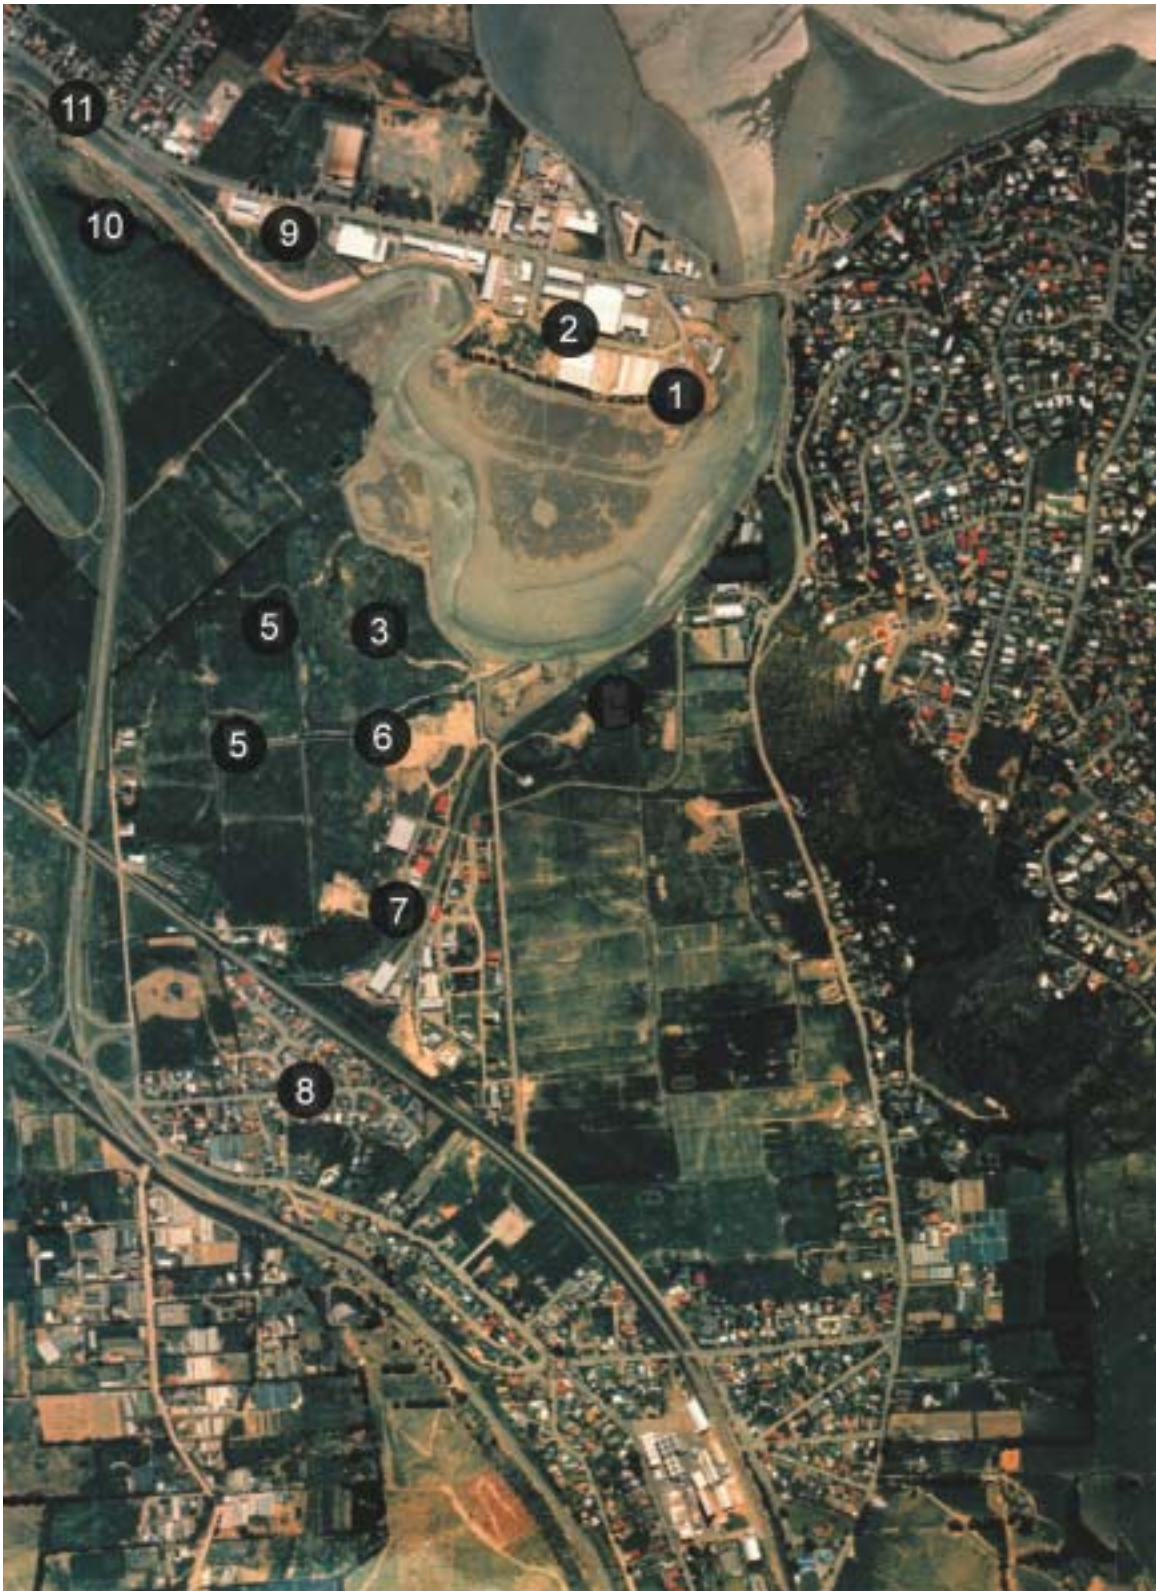
Figure 29. November 1994 aerial photograph (NZ Aerial Mapping)

Compare with figs. 13, 16, 22, 24 & 27. Note: Erosion in all saltmarshes has advanced with the most rapid losses being along the northern margin of Heathcote Loop Saltmarsh where vegetation in the northeast corner has disappeared (1). The pond and saltmeadow in the Settlers Crescent area have now disappeared and are replaced by an industrial subdivision (2). Both Heathcote County Council landfills are now retired and grassed over (3,4). Almost all trace of the original course of Avoca Valley Stream and associated tidal creeks in this area have been lost. A few remnant channels, now largely ephemeral, remain (5). The course of Avoca valley Stream below Tunnel Road has been realigned and now flows in a more or less canalised straight line (6) from west to east. Ferrymead Historic Park occupies a sizeable block along Truscotts Road (7) and is still expanding with several areas of earthworks and construction being obvious. Urban development has occurred between Tunnel Road and the Christchurch-Lyttelton Railway line (8) but has not encroached into low-lying areas further down the valley.

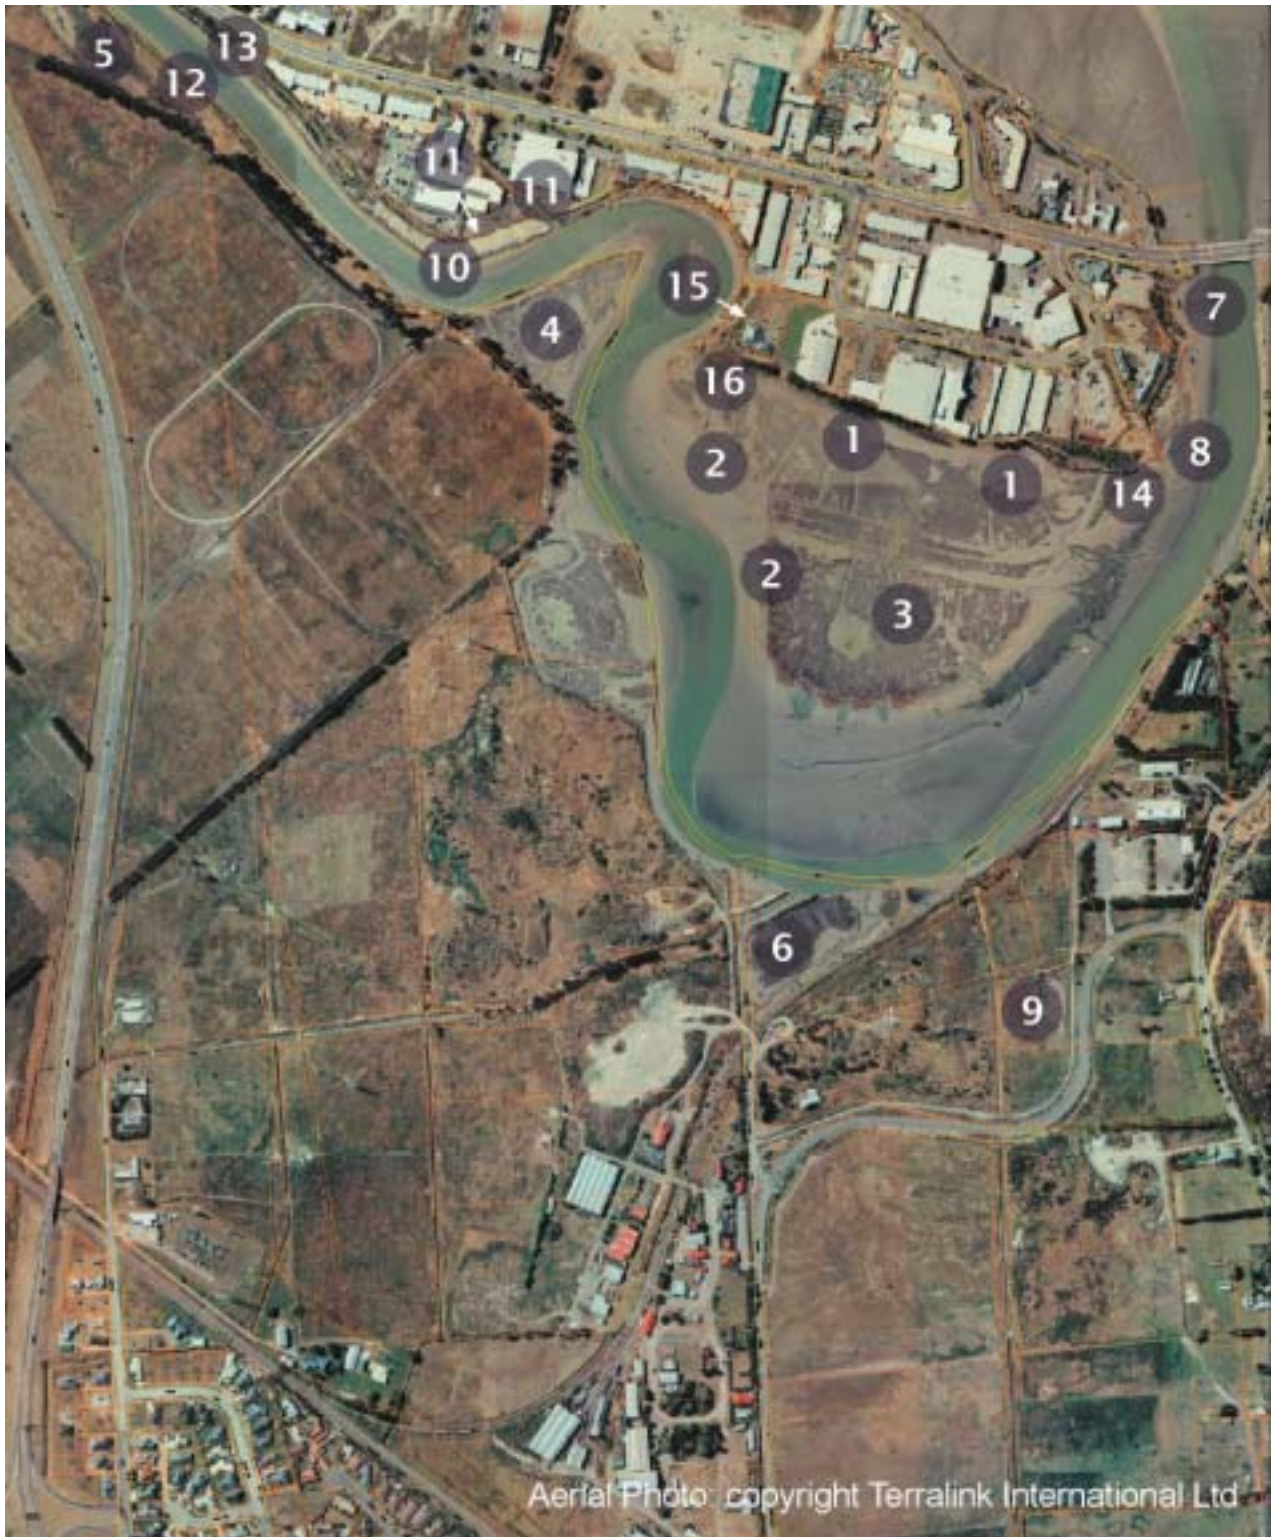
Note: Continued sea rush dieback in Heathcote Loop Saltmarsh, particularly along the northern edge (1), on the western side (2) and the substantial increase of bare batches in the central area (3). Sea rush dieback is also evident at Devil's Elbow Saltmarsh (4) where vegetation cover on the downstream side has become increasingly sparse.

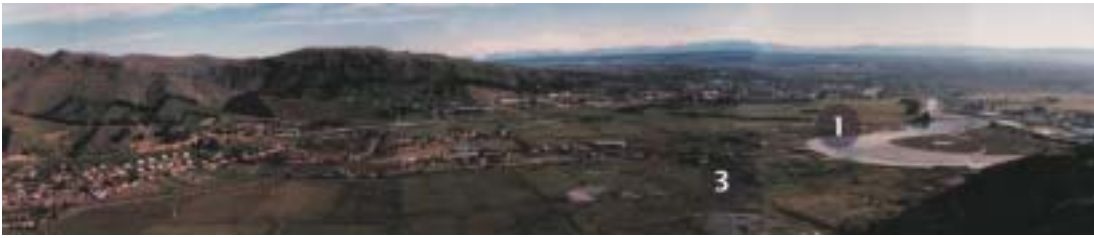
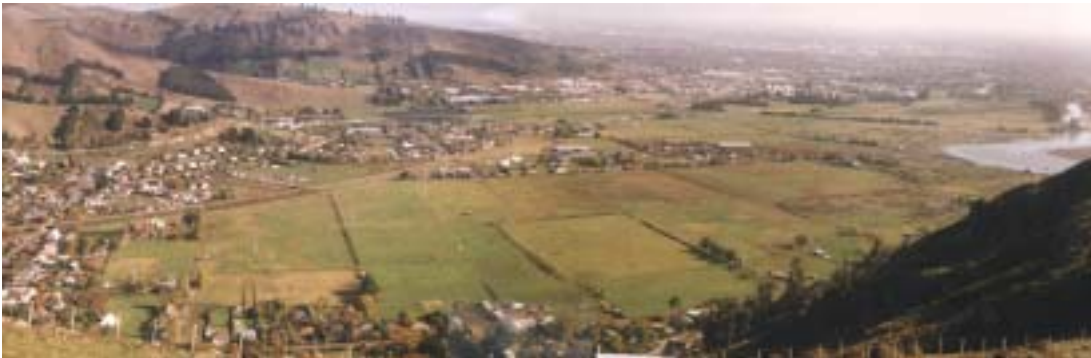
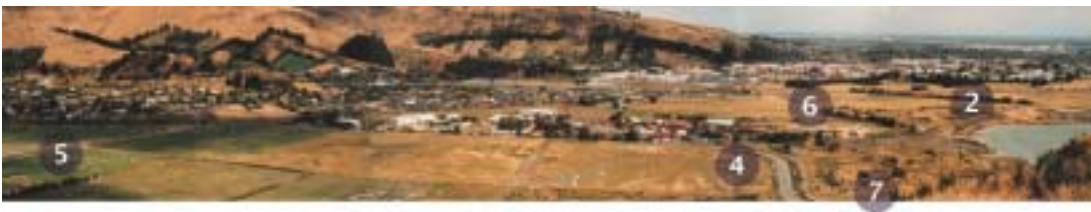
Figures 31, 32 & 33 reveal landscape/habitat changes in the Heathcote Valley between 1988 and 2003. While little habitat loss occurred between 1988 and 1998, the pace of change is now accelerating with renewed housing development around the edges of Heathcote Valley township and plans for considerable recreational and environmental development in the lower valley.

The Heathcote County Council tip (1) was still open in the 1988 photo but has now been closed for some time and is grassed over with a few cabbage trees and flaxes surviving from an unsuccessful 1990 planting project (2). A proposal to develop a golf course on the old land fill is currently before the Christchurch City Council.

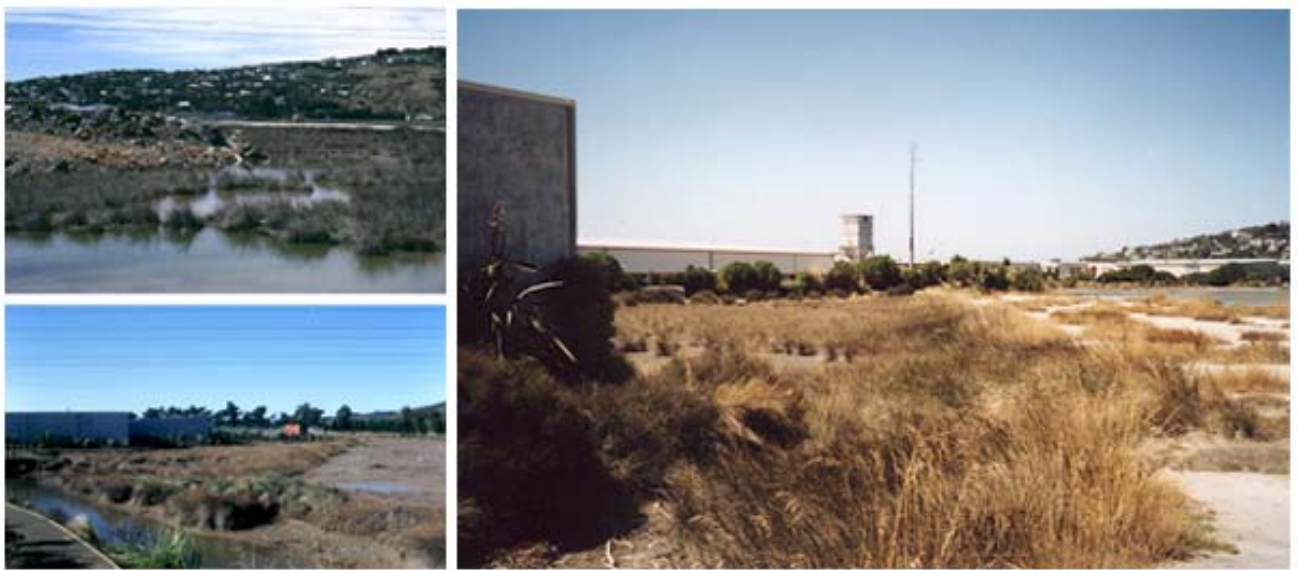
**Figures 34 - 42**  
**Progressive infilling of**  
**Ferry Road Saltmarsh c.**  
**1988 to 2003**  
 (Photos: A. Crossland)

This has continued into the present day with the last 10% of Ferry Road Saltmarsh narrowly saved from reclamation in the late 1990's (see figs. 34 - 43) and destruction of part of Ferrymead Esplanade Saltmarsh currently proposed as part of the planned widening of Ferrymead Bridge.

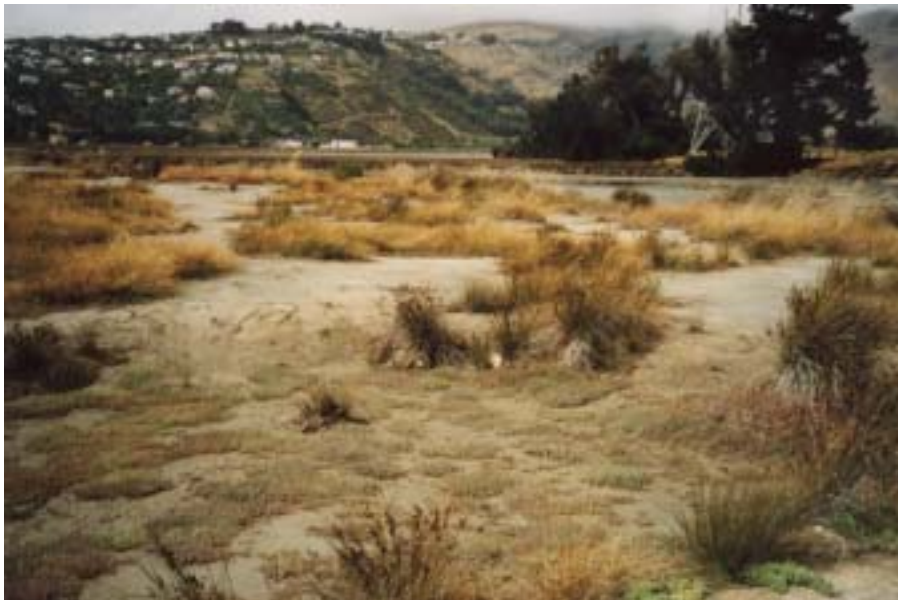
Figure 43. Revegetation of riverbank at Ferrymead Saltmarsh

In the mid 1990's cuttings were made into the riverbank to facilitate the recolonisation of saltmarsh plants. The photograph shows *Sarcocornia* recolonising a scraped hollow.

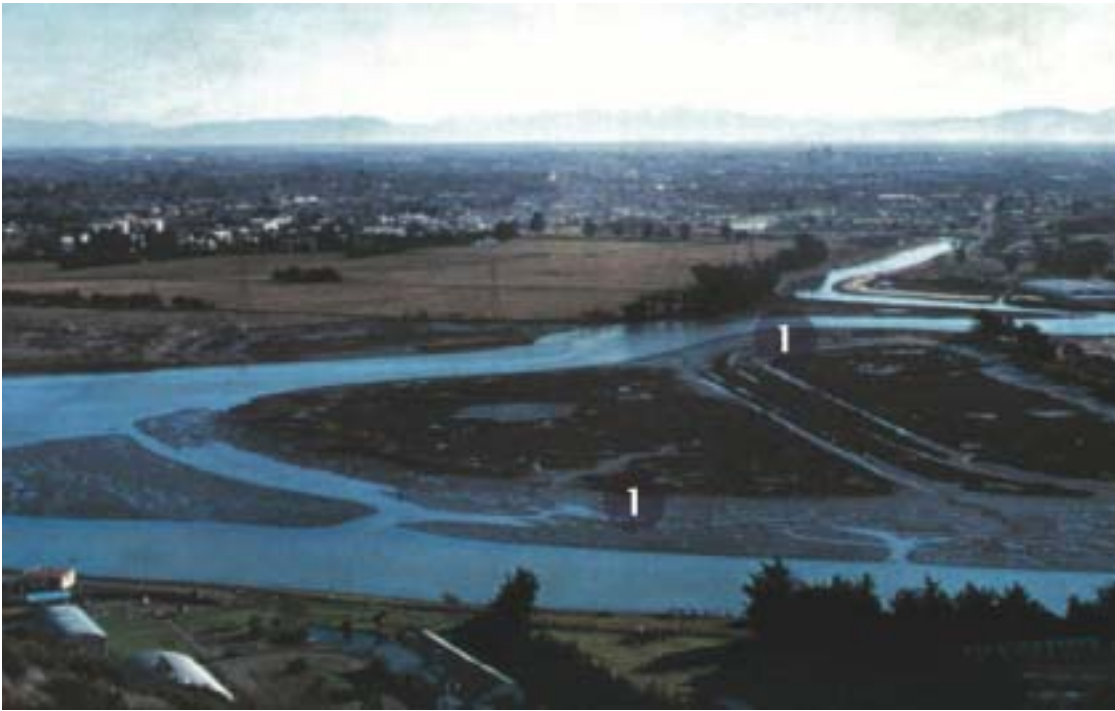
Figure 44 April 1988 view of Heathcote Loop (A. Crossland)

The second major threat to saltmarshes is vegetation dieback. Sea rush communities in Ferry Road, Devil's Elbow, Stilt Island, Heathcote Loop and Ferrymead Esplanade saltmarshes are all disappearing. This die back is evident in aerial photos and its recent acceleration at Heathcote Loop Saltmarsh is shown in a series of oblique elevated photographs in figs 44- 47. Causes are poorly understood and an urgent investigation is required to assess if the process can be halted and/or reversed.
