# Ecological Values and Wildlife Opportunities *of the* ***Lower Heathcote Valley Floodplain***

Report for Parks & Waterways Unit  
Christchurch City Council

Andrew Crossland  
Parks & Waterways Unit. March 2003

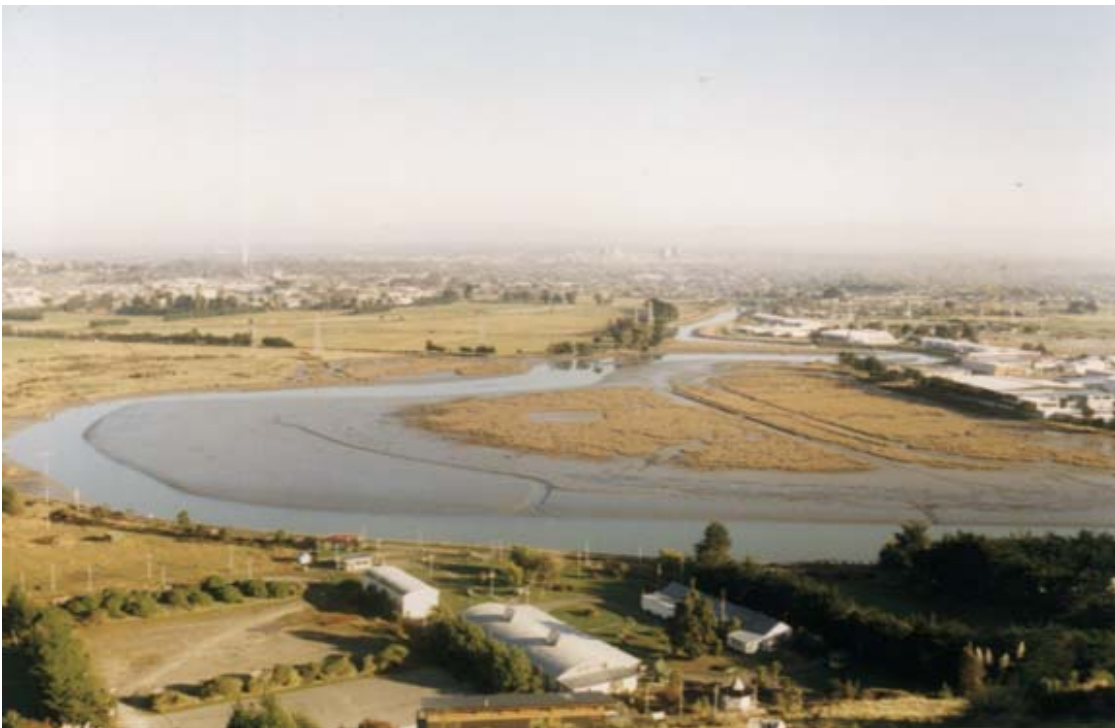
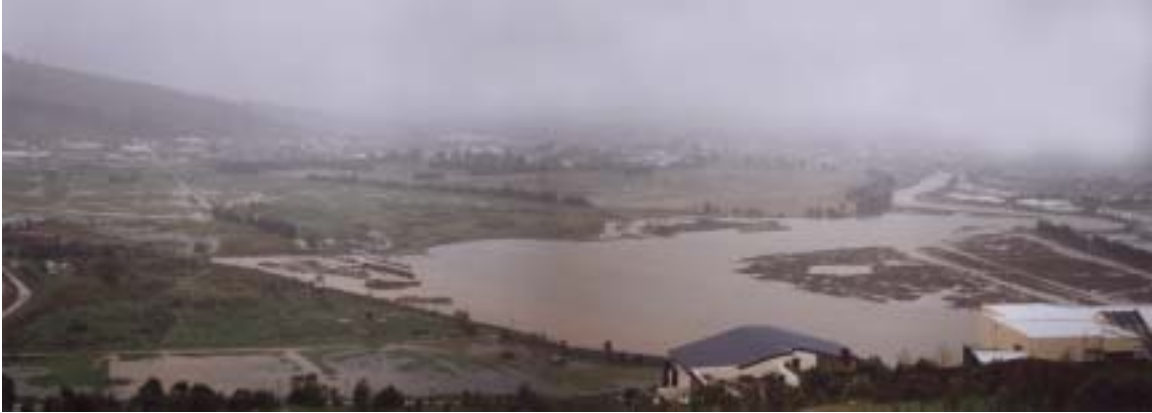
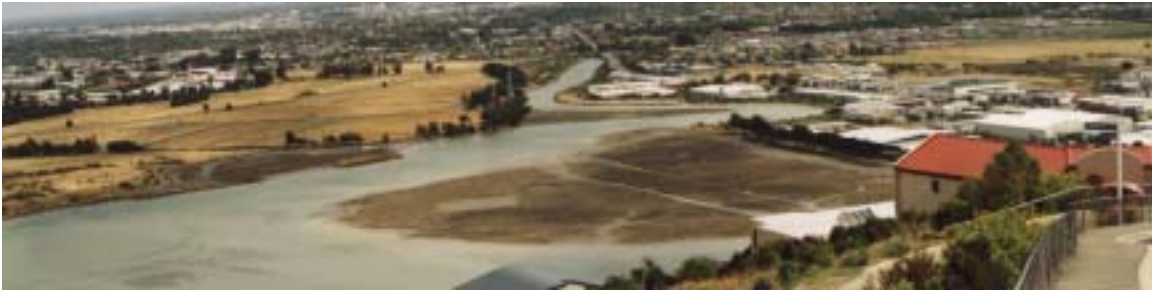
Note: This series of photos shows progressive erosion and vegetation loss around the river-side edges of Heathcote Loop Saltmarsh (1), and through the bare area on the northern side (2). A process of conversion from saltmarsh to mudflat appears to be occurring. On spring tides (3-4 days/month) and during high river flows, much of the saltmarsh habitat within the lower Heathcote River is fully or partially inundated with tidal water.

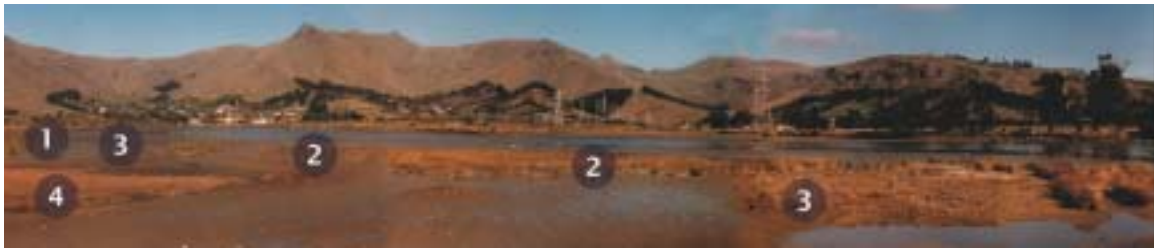
Note: retreating edge of main marsh (1); pockets of sea rush now isolated from the main marsh (2); eroding root systems (3); new mudflats behind old line of vegetation (4); remnant saltmeadow patch (5).

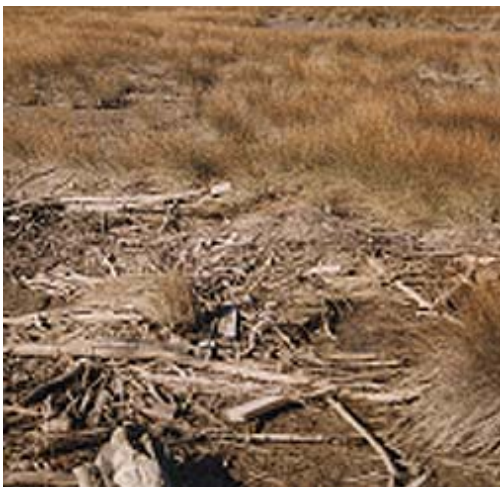
**Figure 49. Driftwood smothering part of Heathcote Loop Saltmarsh** (A. Crossland)

A third threat to saltmarsh vegetation is smothering by driftwood. This involves the formation of large accumulations of wood and other debris over top of saltmarsh vegetation and is a particular problem at Devil's Elbow and Heathcote Loop Saltmarshes. Large areas covered by driftwood are clearly evident (coloured yellow) in Figure 25. Much of this accumulated debris was removed by CCC and Friends of the Estuary in the mid 1990's, freeing up some areas of saltmarsh and saltmeadow vegetation. A repeat of this exercise every 3-5 years is recommended.

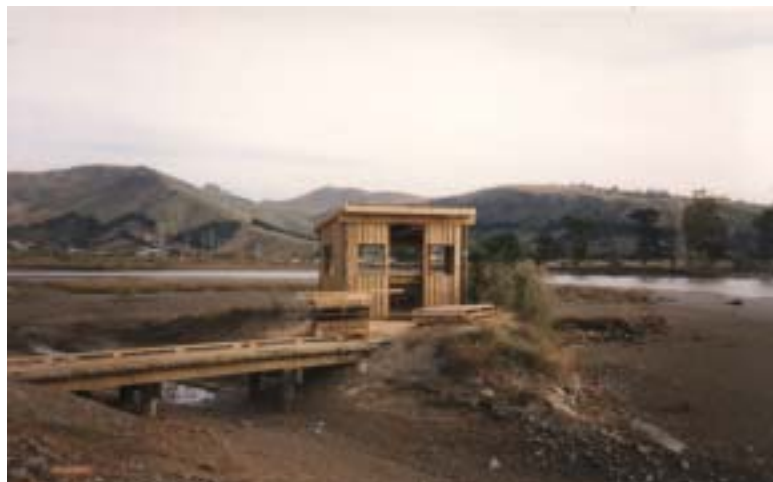
**Figure 50. Area cleared of driftwood accumulation in Heathcote Loop Saltmarsh**  
(A. Crossland)

Clearance of driftwood, habitat restoration work and the construction wildlife observation hide took place in the NW corner of Heathcote Loop Saltmarsh in the mid 1990's. The cleared areas of saltmarsh, saltmeadow and mudflat are now utilised as a roosting site waders and herons.

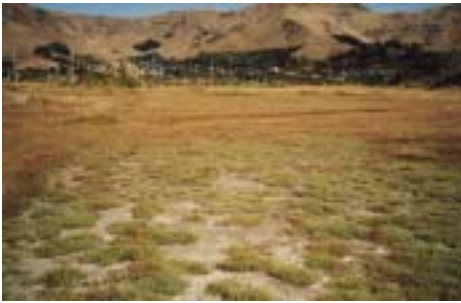
**Figure 51 Ferrymead Saltmeadow** (photo: A. Crossland)

This is the largest saltmeadow remnant within the Lower Heathcote Valley Floodplain. The proposed Tamaki Maori Cultural Village and adjacent waterway will destroy part of this site, although opportunity exists to create replacement saltmeadow habitat further inland in the Truscotts Road paddocks.

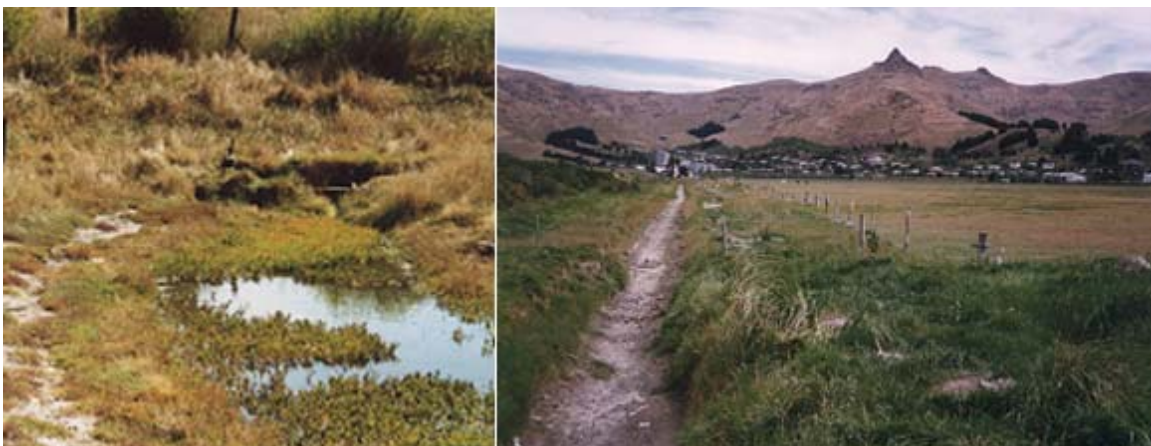
**Figure 52. Tidal swale near Ferrymead Saltmarsh** (photo: A. Crossland)

Historic and aerial photographs reveal that the Lower Heathcote Valley Floodplain was formerly covered in an intricate network of tidal and freshwater creeks. Most have long since disappeared or have been realigned, and the current landscape is criss-crossed by ditches and drains. Several waterways are tidal in their lower reaches and support low numbers of wetland birds. Avoca Valley Stream is the largest of these and although highly modified, its lower reaches supports a good assemblage of wetland birds including Paradise Shelduck, Mallard, Grey Duck, NZ Shoveler, White-faced Heron, Pukeko, Welcome Swallow and NZ Kingfisher. Ditches further inland support low numbers of Pukeko and ducks where they have riparian cover and reliable base flows.

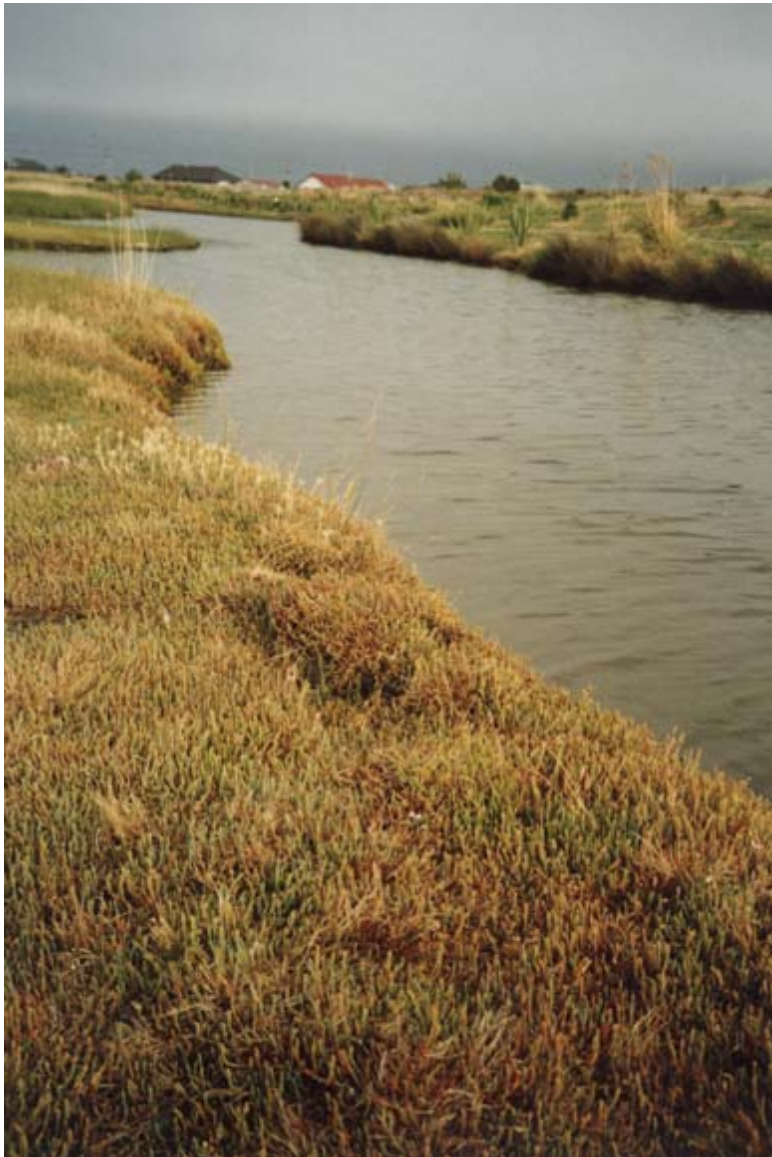
Figure 55. Salt-tolerant vegetation will recolonise suitable sites by itself

Salt-tolerant vegetation such as the *Sarcocornia* shown here recolonising the edge of a tidal waterway at Bexley Wetland, will colonise new sites by itself once environmental conditions (such as inflow of tidal water or concentrations of salts in soils). Weed problems and large-scale revegetation plantings are not generally required with saltmarsh and saltmeadow re-establishment.

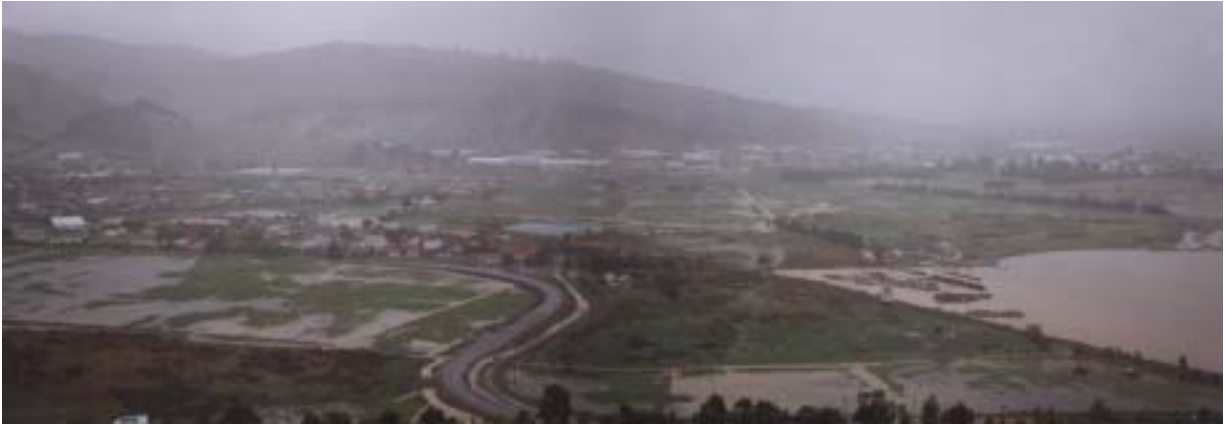
These low-lying paddocks are presently used for horse grazing. Small numbers of Pukeko, Paradise Shelduck, Mallard, Spur-winged Plover, White-faced Heron and Kingfisher regularly occur. In winter, these paddocks are saturated and localised ephemeral ponding occurs. Potential for creation of more permanent pond/waterway/wetland habitat comes from this seasonal wetness and from inflow of both stormwater and tidal water via drains. A wetland created at this site could incorporate a pond basin or saltmarsh core with a wider margin of salt meadow, ephemeral marsh, ephemeral fresh/brackish/tidal pools and wet grassland. Current design plans for the site show a stormwater treatment basin and a waterway link through site (b) to the Heathcote River. This linkage and the relatively large site of the proposed basin are likely to attract a range of wading birds, waterfowl and swampbirds.

Figure 56. Truscotts Road paddocks with surface water ponding during a storm event.

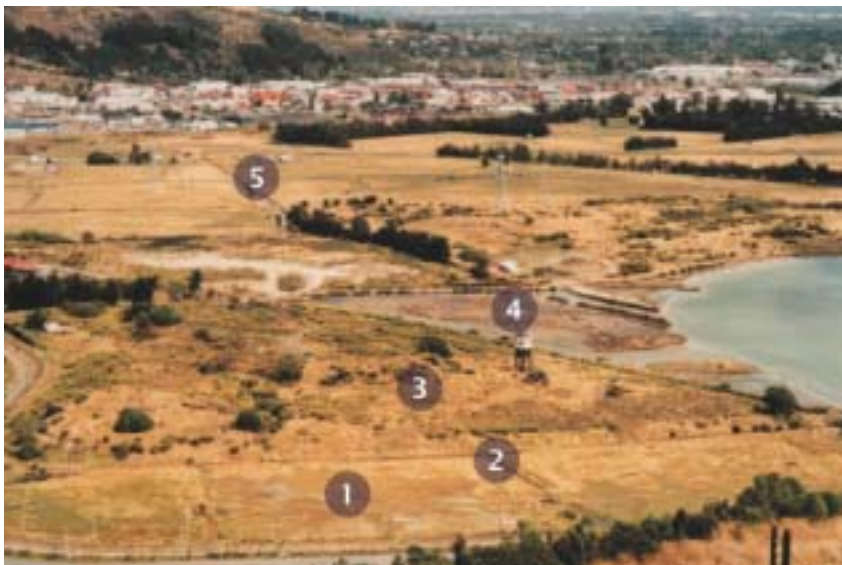
**(b) Ferrymead Saltmeadow and environs**

Note: Ferrymead saltmeadow (1) in the foreground and surrounding horse paddocks. The tidal ditch (2) linking the Heathcote River with the saltmeadow follows the edge of the old landfill (3). This is the proposed site for a new waterway and the Tamaki Maori Cultural Village. Ferrymead Saltmarsh (4) and the low-lying paddocks around lower Avoca Valley Stream (5) are evident in the background.

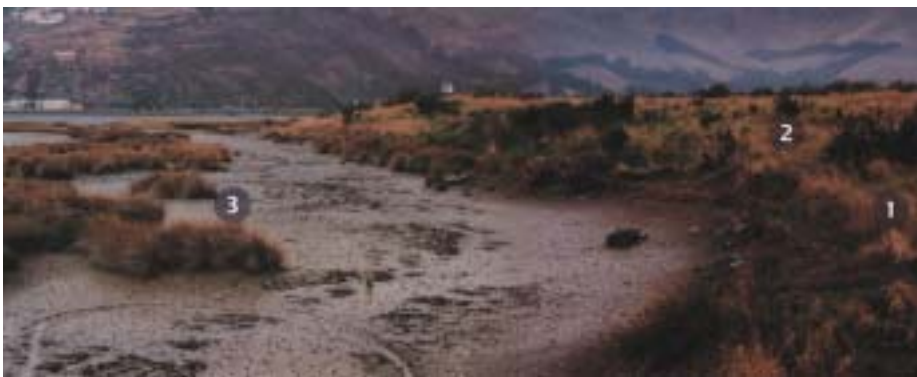
The low-lying earth bund (1) requires breaching to allow tidal inflow into the low-lying area at the toe of the old H.C.C landfill (2). Stilt Island Saltmarsh is located immediately adjacent – note dieback of sea rush cover (3).
