# Water Quality and Ecological Health Assessment of Mugford Drain

By Ella Peoples

For the Avon-Heathcote Estuary Ihutai Trust

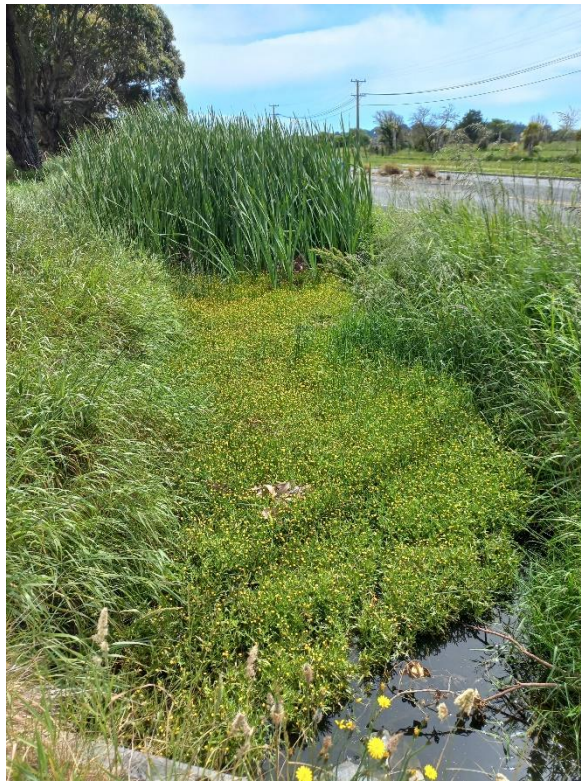
Figure 1: The source of Mugford Drain is characterized by poorly defined margins and thick aquatic vegetation growing in the waterway.

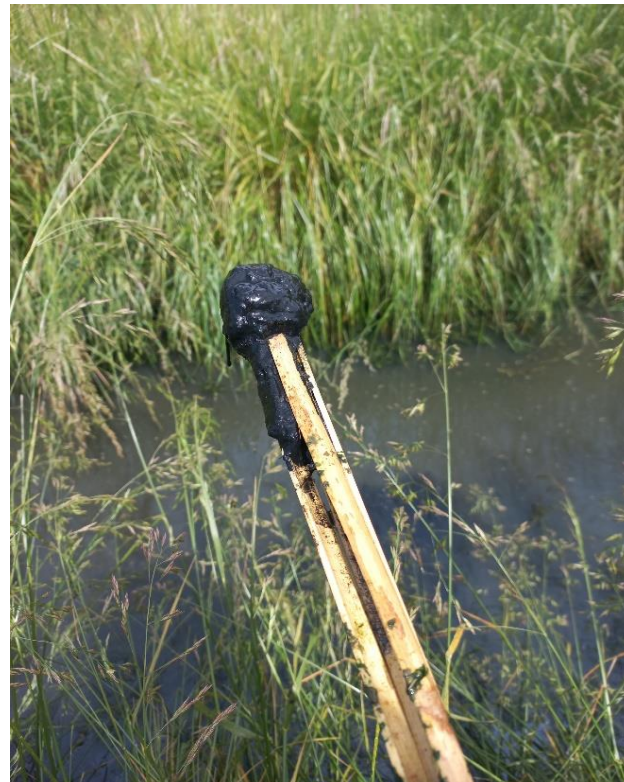
Figure 2: The colour and consistency of the muddy bottom which covers much of Mugford Drain.

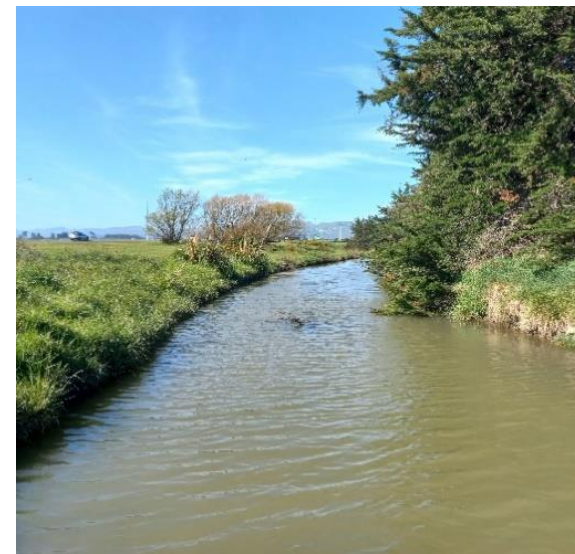
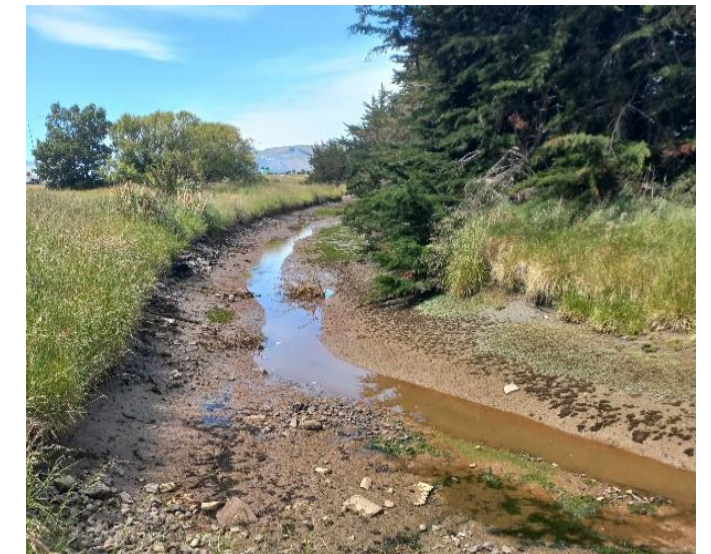
Figure 3: Water levels at high (left photo) and low (right photo) tides at the Estuary Drain. Also visible is the red mud, characteristic of the Estuary Drain.

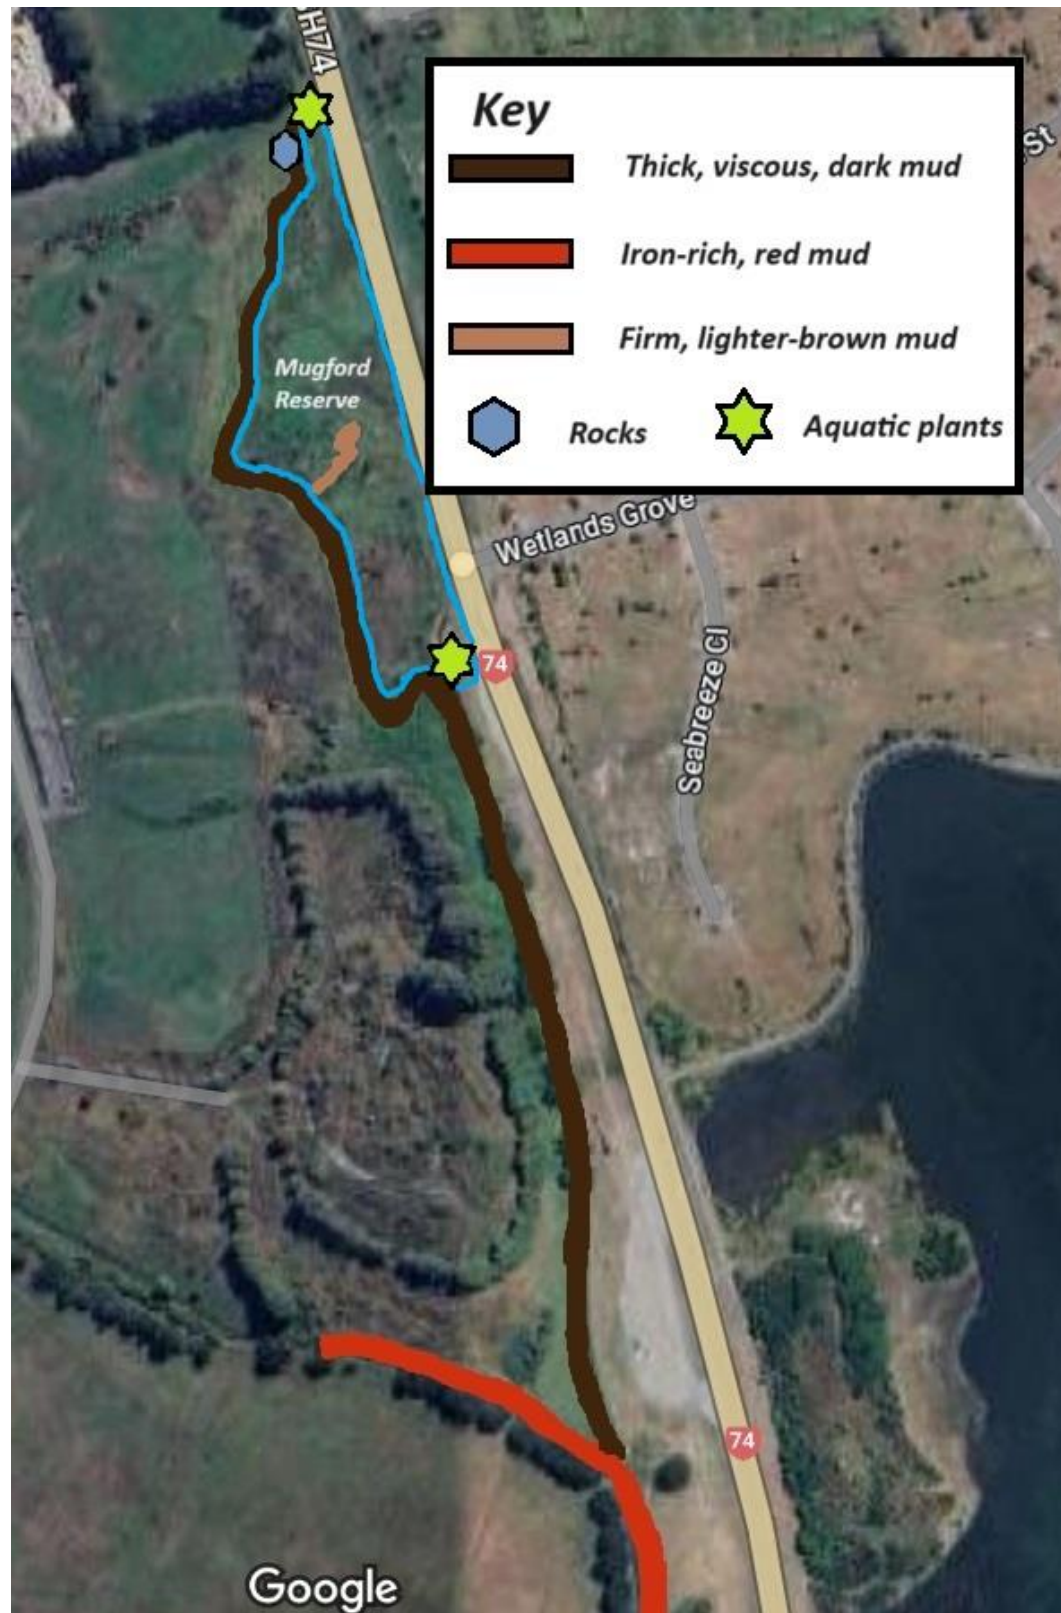
Figure 4: Map of the different bottom types found in Mugford and Estuary drains.

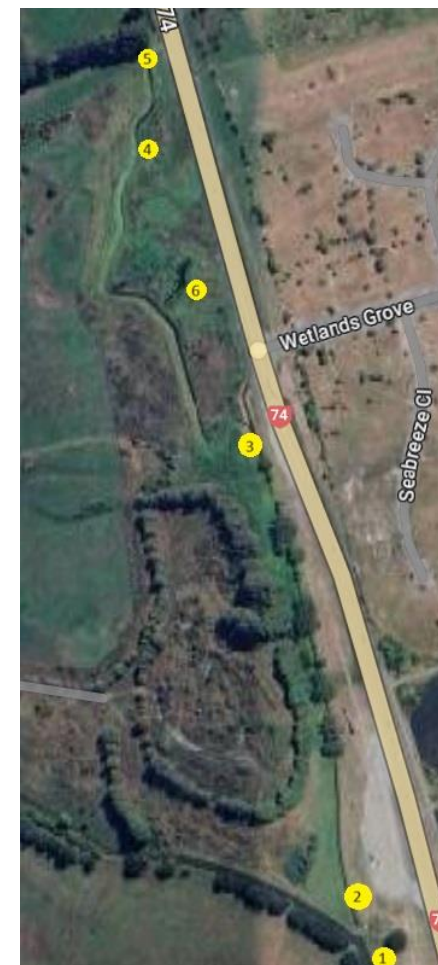
Figure 5: Map showing the water testing sites.

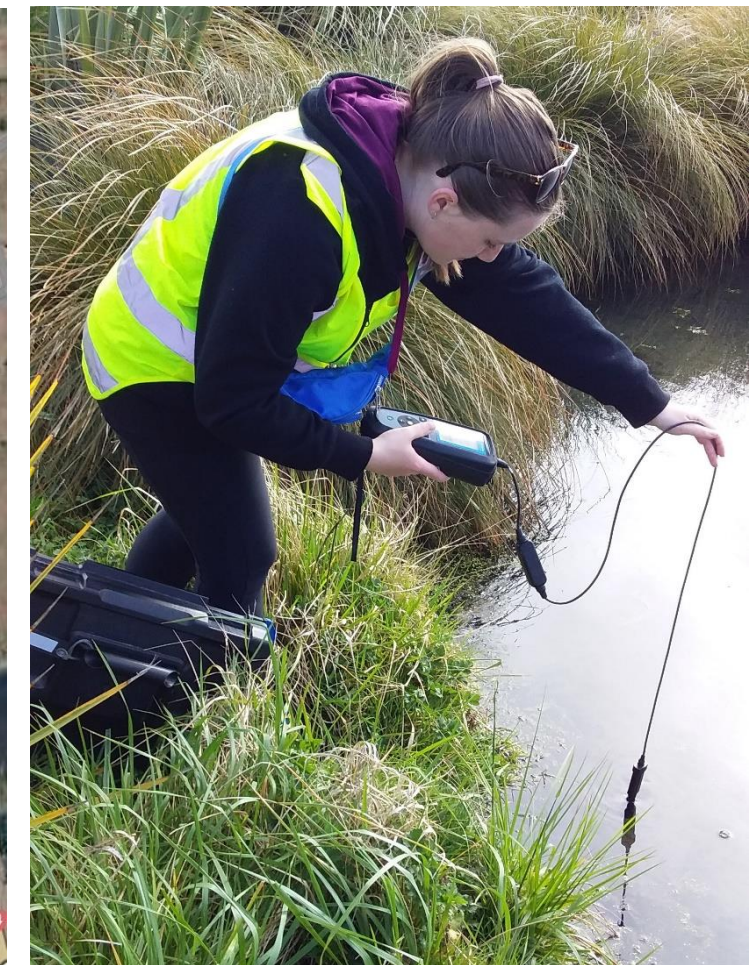
Figure 6: A demonstration of typical water sampling methods.

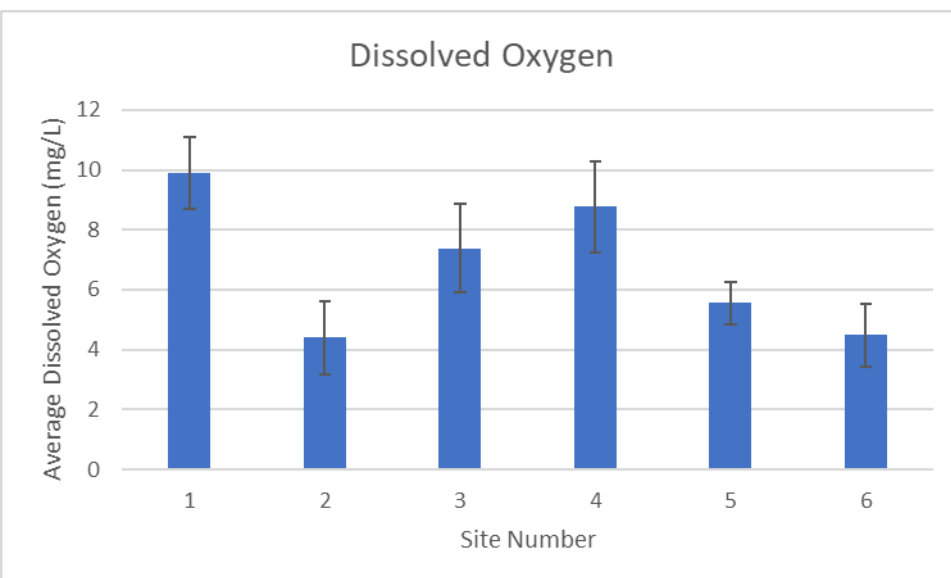
Dissolved oxygen varied between sites, with sites 2 and 6 having the lowest concentrations, and sites 3 and 4 having the highest concentrations (Fig 7). A notable anomaly in the dissolved oxygen readings occurred in early September at site 4, where the dissolved oxygen readings were beyond the scale of what could be measured by the probe. This was around the time that a large mound of vegetation was blocking the drain's flow downstream of site 4; readings were normal downstream of the blockage. Many factors can affect the concentration of dissolved oxygen in a waterway. As water temperature increases, the amount of dissolved oxygen in the water decreases, therefore temperature can play a major role in determining the concentration of dissolved oxygen. The flow of water can also determine the concentration of dissolved oxygen – faster flowing water has more dissolved oxygen. Biological oxygen demand (BOD) describes how much oxygen is taken up from the water by organisms, and if BOD is high, this can lead to low concentrations of dissolved oxygen. This can particularly be an issue if there are large amounts of bacteria in the water, which consume a lot of oxygen. Algal blooms can also cause elevated concentrations of dissolved oxygen when they photosynthesize during the day but consume oxygen overnight, leading to lower dissolved oxygen concentrations. It is likely that the drain blockage allowed algae to bloom and produce great amounts of dissolved oxygen. The minimum level of dissolved oxygen for fish to survive and spawn is 5.99 mg/L or 6 ppm. Below this level, fish become stressed. At concentrations of 3 mg/L or lower, fish cannot survive (Atlas Scientific 2022). Concerningly, the dissolved oxygen readings at Mugford stream were lower than the threshold for spawning on many occasions, and some readings fell into the lethal range too.

Figure 7: Average dissolved oxygen across sites at Mugford and Estuary Drains. Dissolved oxygen is highest at sites 3 and 4. Error bars show standard error.

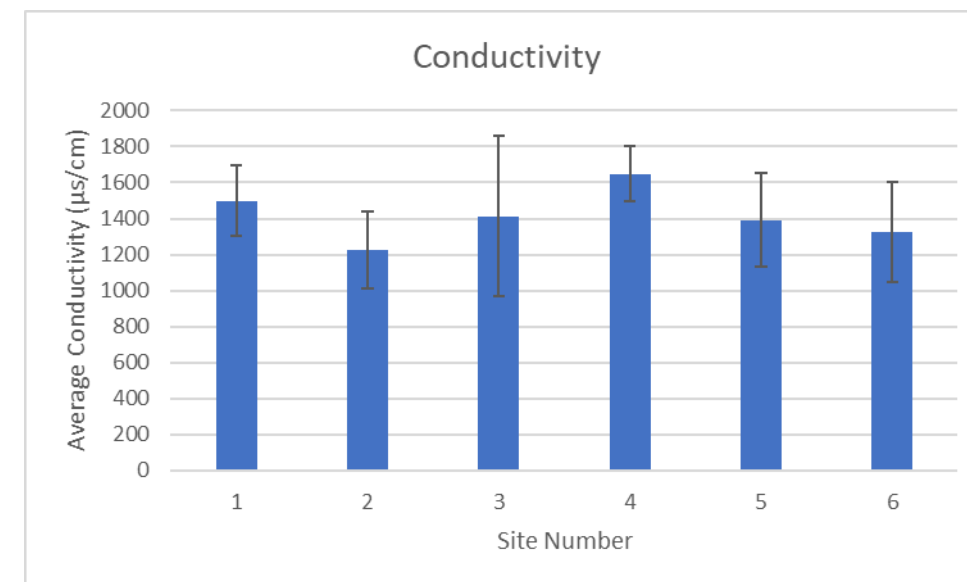
Conductivity measures how well a substance can carry an electrical current. The salinity of water strongly influences its conductivity, as salts allow electrical current to flow easily through water. Therefore, the conductivity of water in the drains varies depending on the tide, particularly in the Estuary Drain, which is more affected by the tide due to its proximity to the estuary. Site 6 has the lowest conductivity as this is where fresh water wells up from the spring into Lake Jason, while sites 4 and 5 have the highest conductivity (Fig 9). Conductivity is affected by the amount of dissolved ions in the water. High conductivity in freshwater can also be an indicator of pollution, most likely from sewage or agricultural runoff (Atlas Scientific 2022). Sea water conducts electricity well due to the dissolved salts in it, and backwash from the estuary at high tide can alter the conductivity of the drains. Runoff from the highway may be an additional pollution source in the drains.

Figure 8: Average conductivity across sites at Mugford and Estuary Drains. Conductivity is much lower at site 6 than the other sites, which is expected as this is a spring-fed pond.

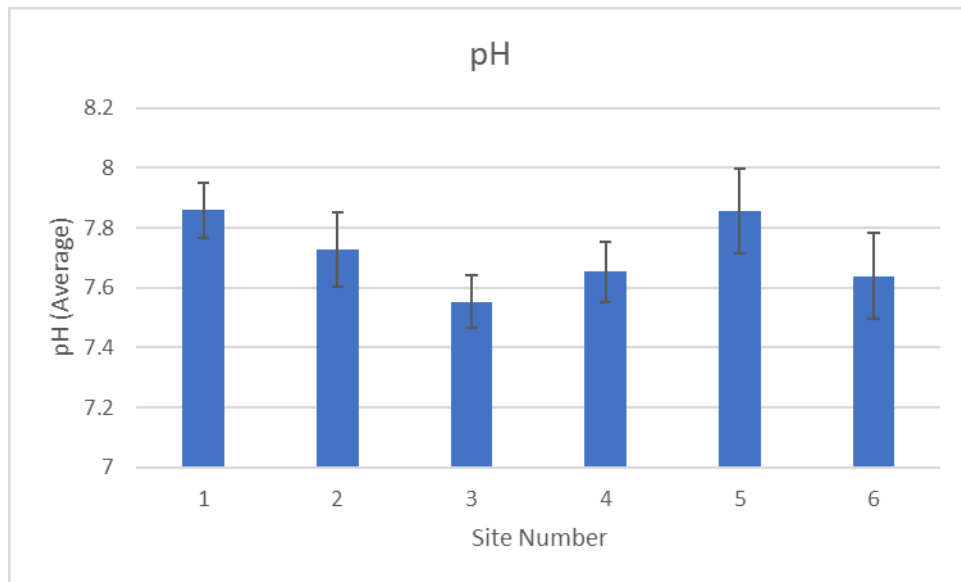
The pH readings taken at the Estuary Drain are consistently lower than readings taken at Mugford or from the spring-fed pond (AKA Lake Jason). pH varies between sites, with the Estuary Drain having a lower pH than other sites, while sites 3 and 4 had the highest pH (Fig 8). pH can be affected by several factors including water temperature, the composition of bedrock and soil under and around the waterway, and anthropogenic inputs into the waterway (United States Environmental Protection Agency 2023b). Readings were all within the safe limits for aquatic organisms and were typical of a semi-tidal stream. Sea water tends to have a pH of around 8.2, while the pH of freshwater ranges between 6.5 and 8.0 (United States Environmental Protection Agency 2023c). The pH of the drain does not seem to increase with proximity to the estuary, but the tidal cycles may have a more complex effect on pH variation in the Mugford and Estuary drains.

Figure 9: Average pH across sites at Mugford and Estuary Drains. pH is considerably lower at the Estuary Drain compared to the Mugford Drain sampling sites. Error bars represent standard error.

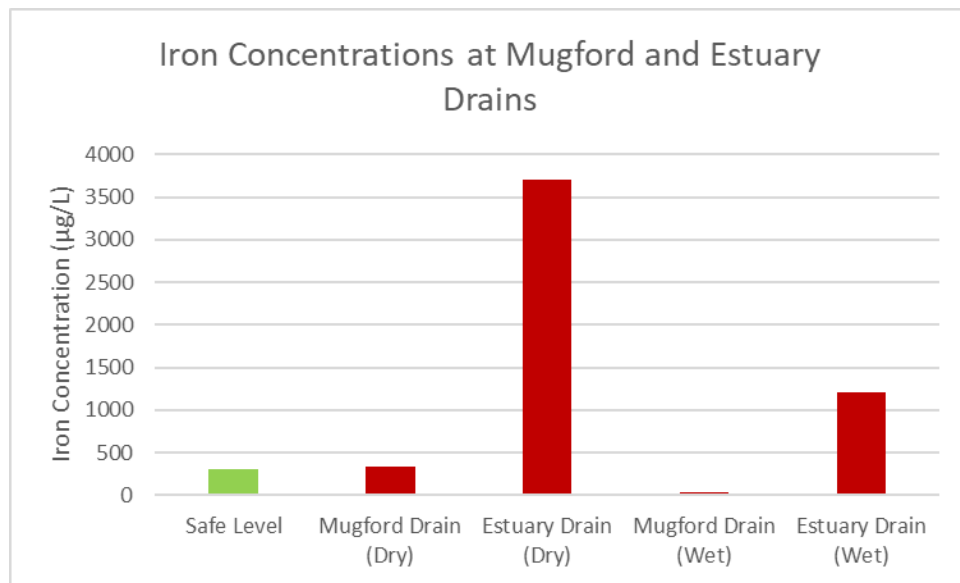
There is no current official guideline concentration for iron in aquatic ecosystems in NZ and Australia, so the Canadian guideline of 300 µg/L was used as a set safe level for the recorded values to be assessed against. The water in Mugford Drain exceeded the safe level during dry weather sampling in October but was well below the safe level during wet weather sampling in November. The water in Estuary Drain exceeded the safe level by more than ten times in October and more than three times in November (Fig. 11). This is consistent with the 2022 Pattle Delamore report. While iron is an essential nutrient in the natural environment, iron toxicity can also have adverse effects on aquatic life in high concentrations. Fish experiencing chronic exposure to iron toxicity tend to experience symptoms including lethargy, inactivity, gill discoloration, disorientation and swimming abnormalities (Roberts, 2023).

Figure 11: Concentration of dissolved iron at Mugford and Estuary Drains (red) compared to the safe standard (green). Levels are very elevated at the Estuary Drain site.

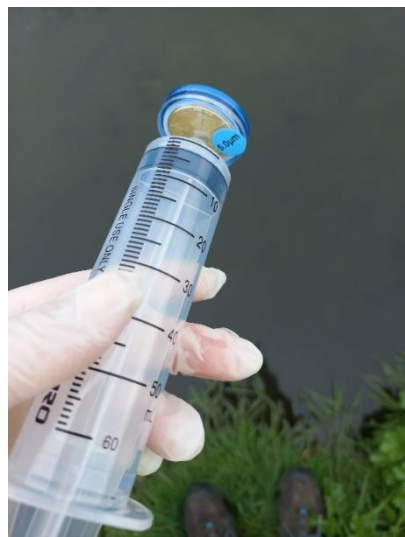
Figure 14: The apparatus used for eDNA sampling.

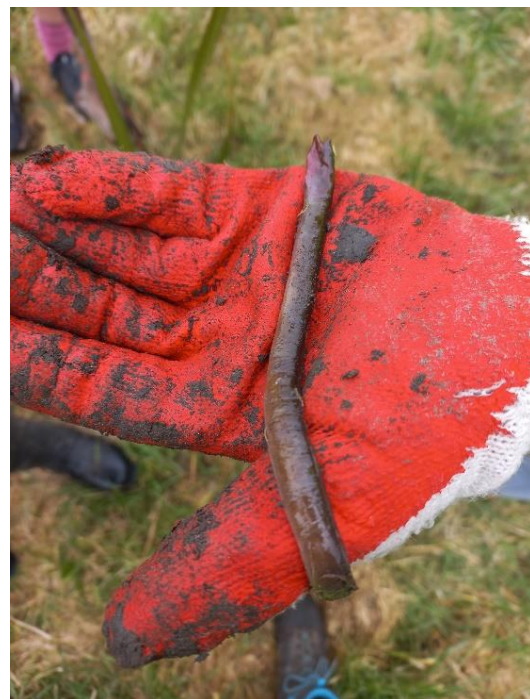
Eels have been spotted in Mugford Drain on at least two occasions. Volunteers at a Forest & Bird Youth tree planting found a dead eel on the stream bank (species indeterminable) in August 2023 (Fig 16). Estuary Trust volunteers also sighted eels in the stream while wading through the water to remove vegetation that was blocking the waterway. From description, these were most likely shortfin eels. Smaller eels ranged in size from 20 – 40 cm, while larger eels were also sighted. Size is strongly correlated with age in many eel species, meaning that a range of different age classes are likely present in the drain (Simon 2007).

Figure 16: A dead eel of uncertain species (either *A. australis* or *A. dieffenbachii*). Found by volunteers in August 2023.

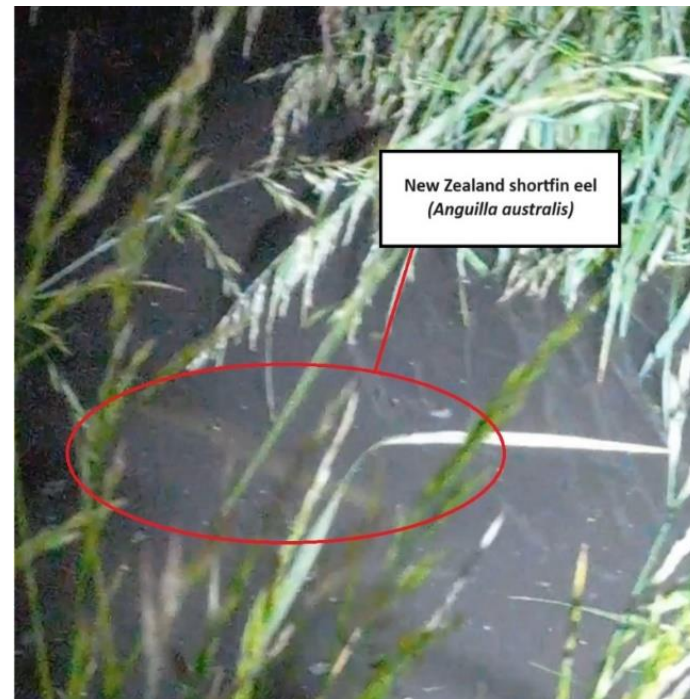
A night walk of Mugford Drain was used to provide an indication of eel abundance. Seven eels of varying sizes were sighted in the drain. Several of these were positively identified as shortfin eels, which is consistent with environmental DNA results from the site. Photos were taken but on later inspection eels were either not visible in these or were extremely blurred and therefore the images have not been included in this report. Video evidence of the eels was obtained and a screenshot from this video has been added below (Fig. 17). While not regularly visible during the day, eels were abundant in Mugford Drain at night. The eels observed were very active and appeared to be in good health, displaying normal swimming behaviour.

Figure 17: A New Zealand shortfin eel/tuna sighted while spotlighting at Mugford Reserve at night. Sighted in November 2023.

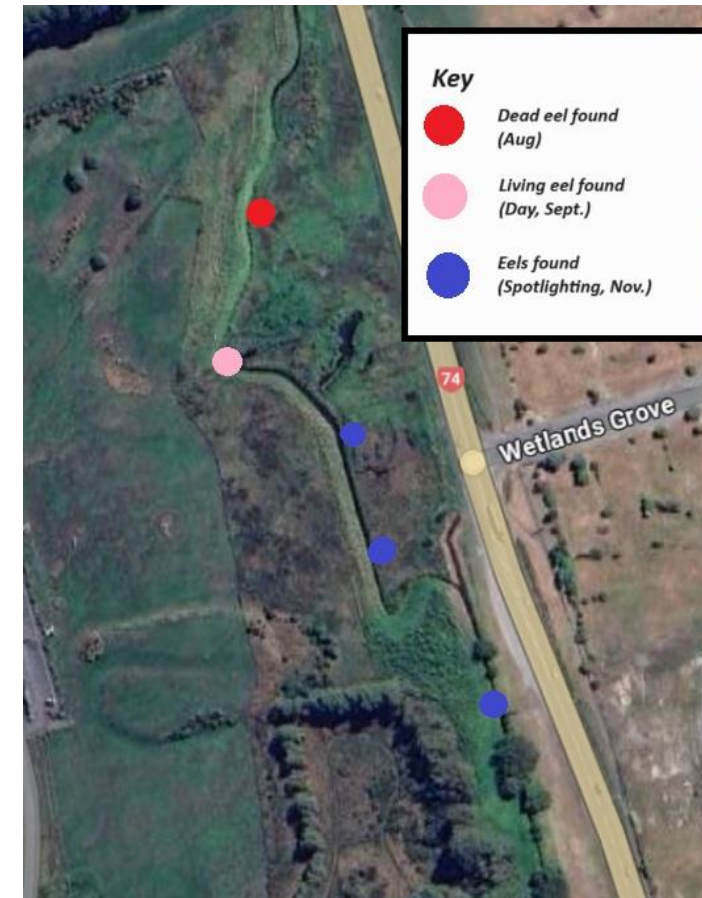
Figure 18: Map of sightings of eels at Mugford Drain.
